**MOORPARK CITY COUNCIL  
AGENDA REPORT**

**SUBJECT:** Consider Approval of the High Street Pepper Tree Recommendation Plan for the Removal of Fourteen (14) California Pepper Trees with a High Risk of Structural Failure

High Street Peppers  
12/15/2011

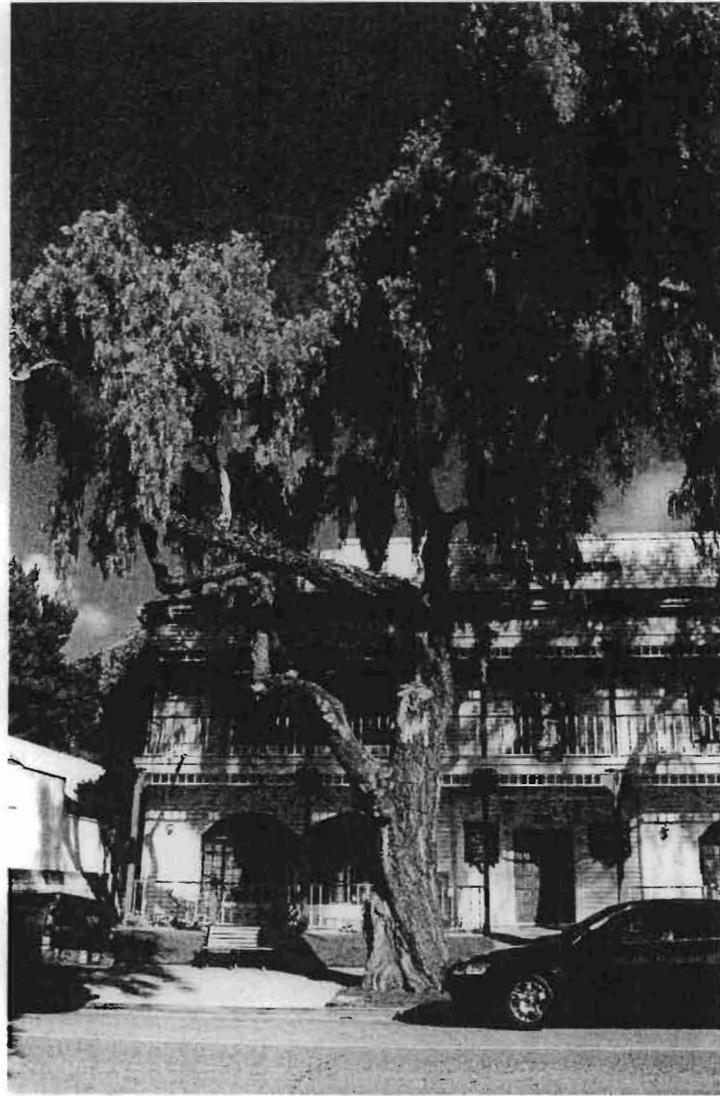
Tree #8

**Tree #8** is an historic senescent tree. Although the tree appears to be healthy and displays average vigor with new shoot growth, it also contains severe structural defects that compromise its structural stability. Signs indicate a history of limb failure on the south side of the tree. The NW lower lateral limb contains a large wound site with cavities and pockets of decay that affect limb stability. A large cavity and area of decay was observed at the base of the trunk on the south side; the trunk of the tree measures 47 inches in diameter just above the soil and the cavity measures 41 inches in depth; in this case I would consider trunk stability severely compromised. The crown of the tree is unbalanced with the majority of its canopy to the north side the trunk. This tree contains severe structural defects with an estimated 6 inches of sound wood in the outer shell of the trunk in the area of the cavity. I believe this tree poses a high risk for structural failure and due to conditions of instability that cannot be reasonably mitigated the tree should be removed immediately. If the tree is to remain in place I recommend a root crown excavation and inspection, and possibly dill testing to measure decay/cavities.

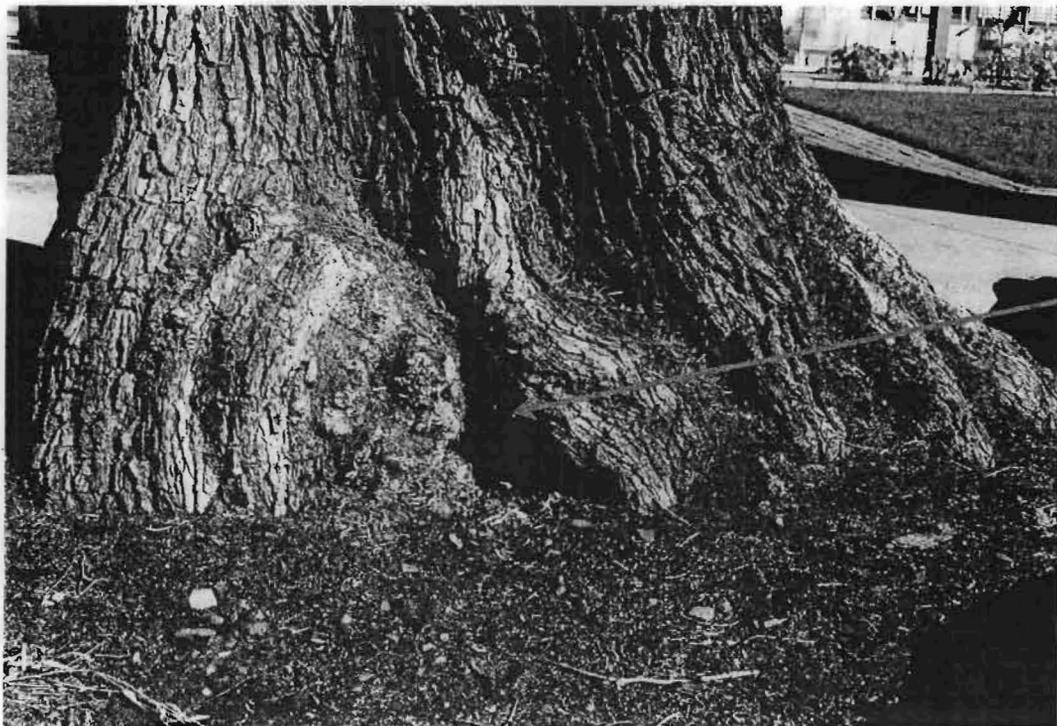
Tree #8 cavity at base of trunk

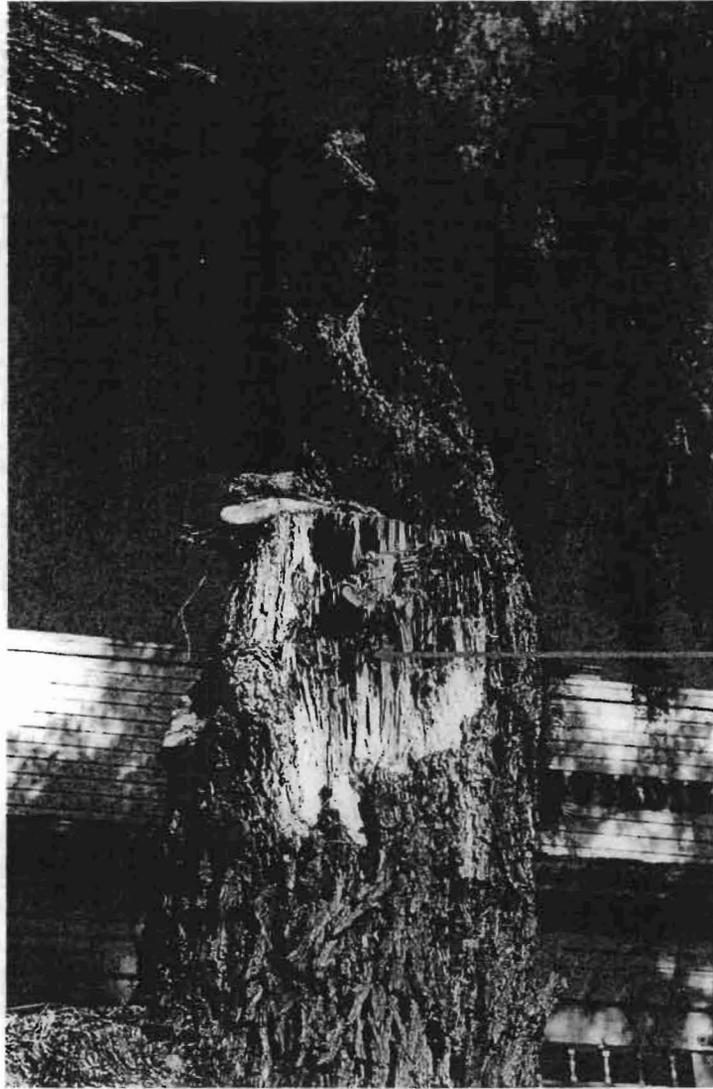
Tree#8 site of limb failure

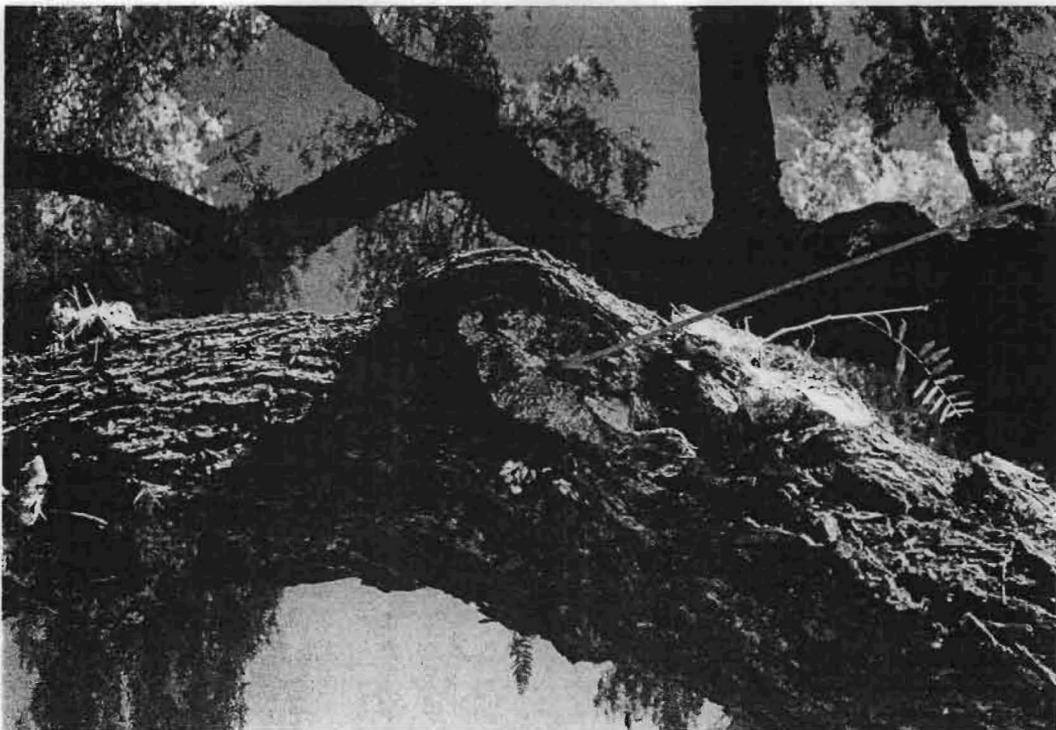
Tree #8, decay at site of past limb failure

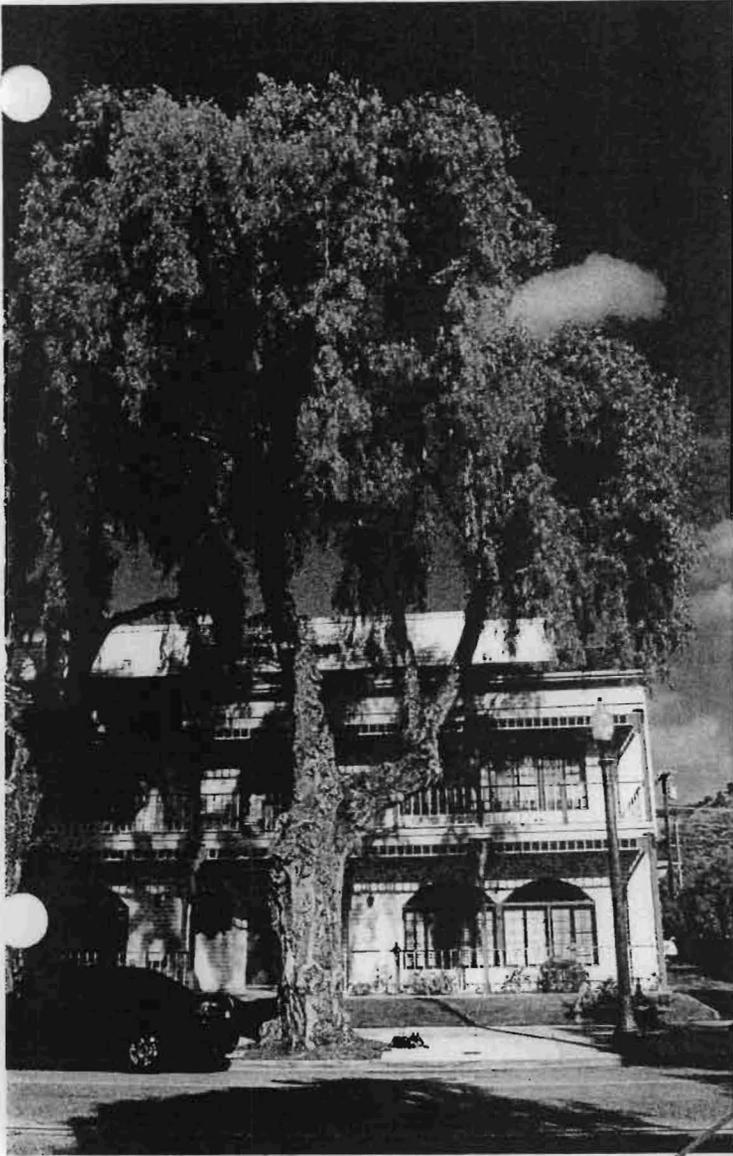
**Tree #9** is an historic veteran tree that is senescent. Although the tree appears to be healthy and displays good vigor with average new shoot growth, it also contains severe structural defects. The trunk contains a large cavity and area of decay on the SW side approx. 9' up from the ground, this is the site of a past limb failure or removal. Sounding of the trunk revealed a distinct hollow sound that indicates advanced internal decay/cavity. By use of a metal probe, multiple deep cavities were confirmed on the south side of the tree just above soil level.

A cavity in the upper portion of the trunk on the SW side likely has column of decay/cavity running all the way to ground level. Clusters of winged insects on the base of the trunk have been visually identified, as subterranean termites and are an indication of dead decayed wood above and or below ground.

Tree #9 contains severe structural defects such as cavities and decay in its main stem, which severely compromise its structural stability and its ability to reasonably support itself. I believe this tree poses a high risk for structural failure and due to conditions of instability that cannot be reasonably mitigated the tree should be removed immediately. Should you decide to keep the tree in place it is recommended that a root crown excavation and inspection be performed to help identify and measure defects and better assess risk.

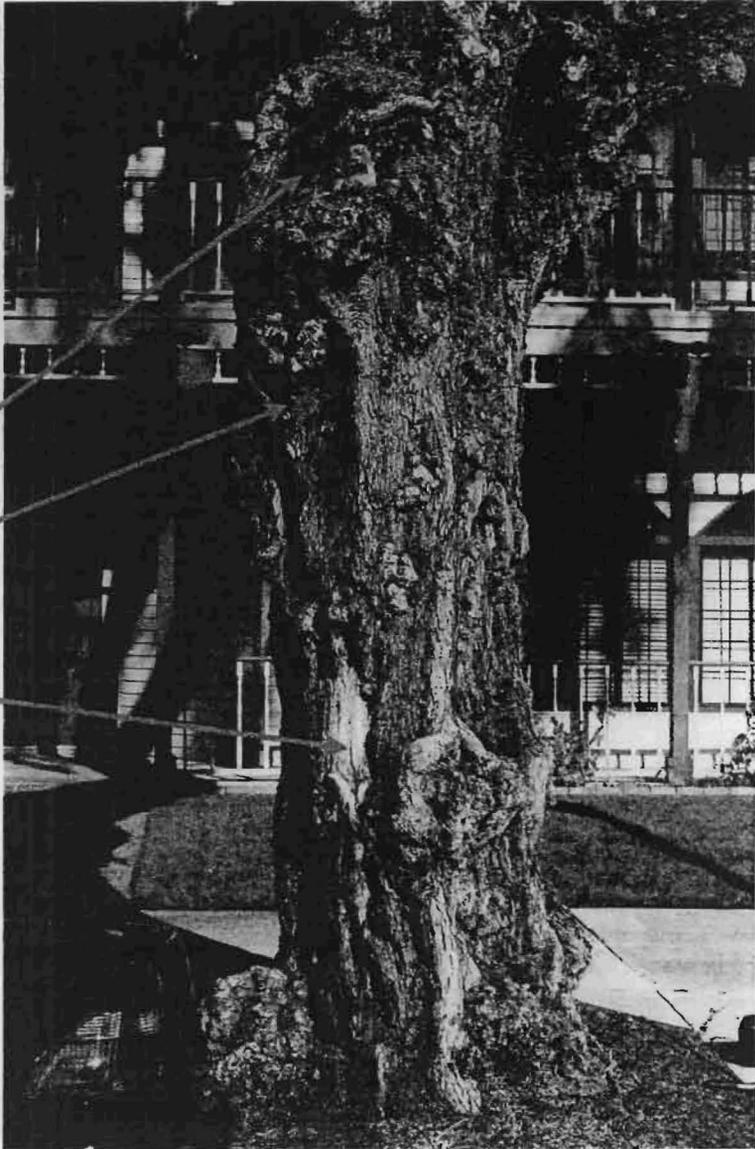
Tree #9, decay and cavities in main trunk

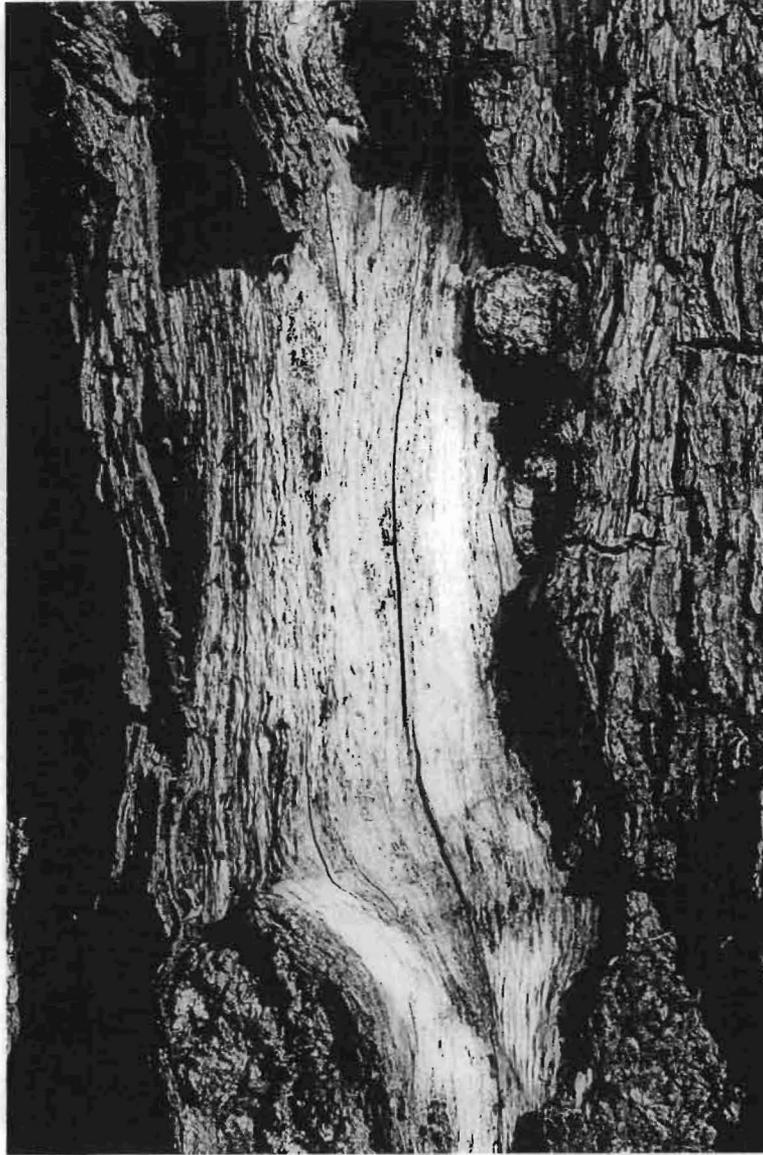
Tree #9, area of dead wood with in main trunk

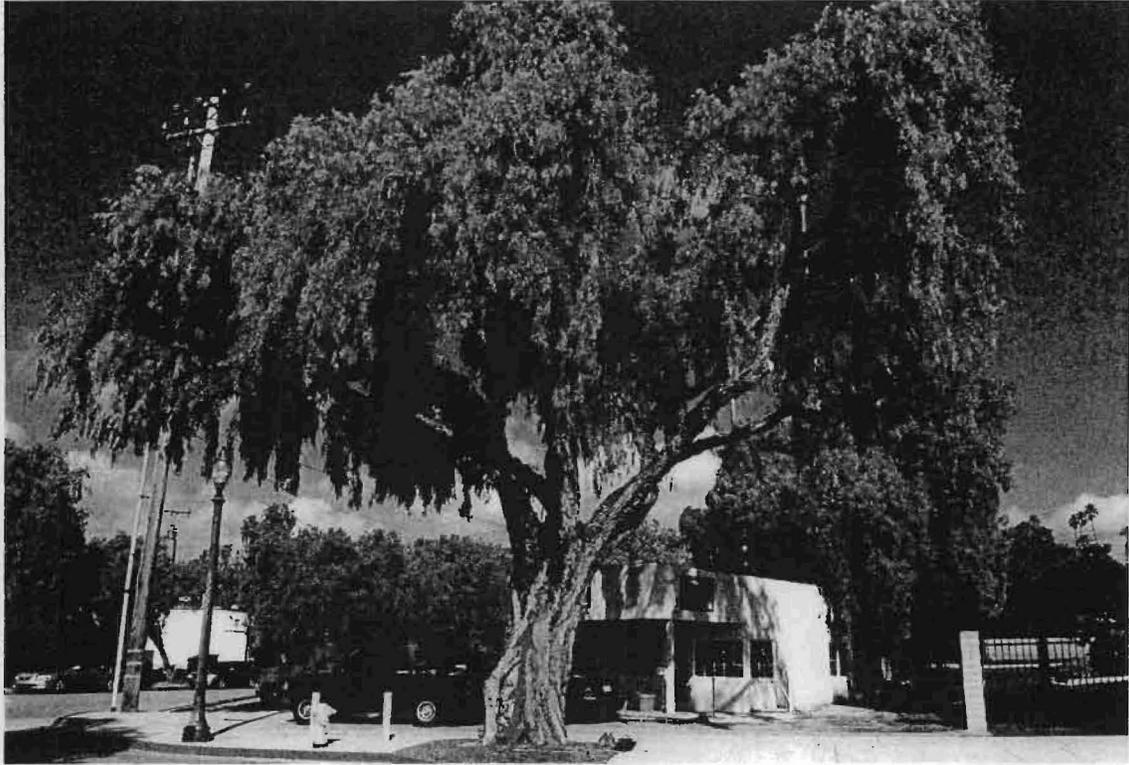
**Tree #13** is an historic veteran tree that is senescent. Although the tree appears to be healthy and displays good vigor with abundant new shoot growth, it also contains severe structural defects that deem it unstable. There is a large area of deadwood on the lower south side of the trunk. Soft decayed wood and cavities were observed and detected in various areas around the lower trunk. Probing revealed a 31" deep cavity on the south side of the tree at the base of the trunk, a 26" deep cavity on the north side 3 feet above the ground, and a 19" deep cavity on the SE side at 6.5 feet above the ground. Due to the number and severity of defects I consider the stability of this tree to be extremely compromised.

Tree #13 contains severe structural defects such as cavities and decay that seriously compromise its trunk and scaffold limb stability. I believe this tree poses a high risk for structural failure and due to conditions of instability that cannot be reasonably mitigated the tree should be removed immediately. Should you decide to keep the tree in place it is recommended that a root crown excavation and inspection be performed to help identify and measure defects and better assess risk. Keep leaf debris cleared from base of trunk to expose root collar.

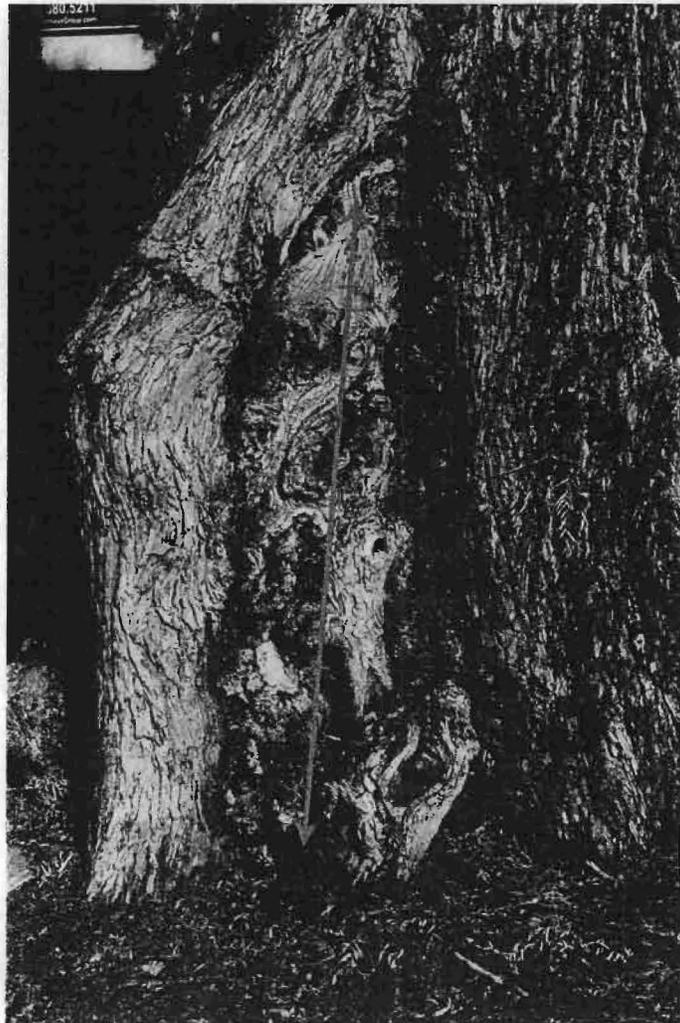
Tree #13, large wound and area of decay base of trunk

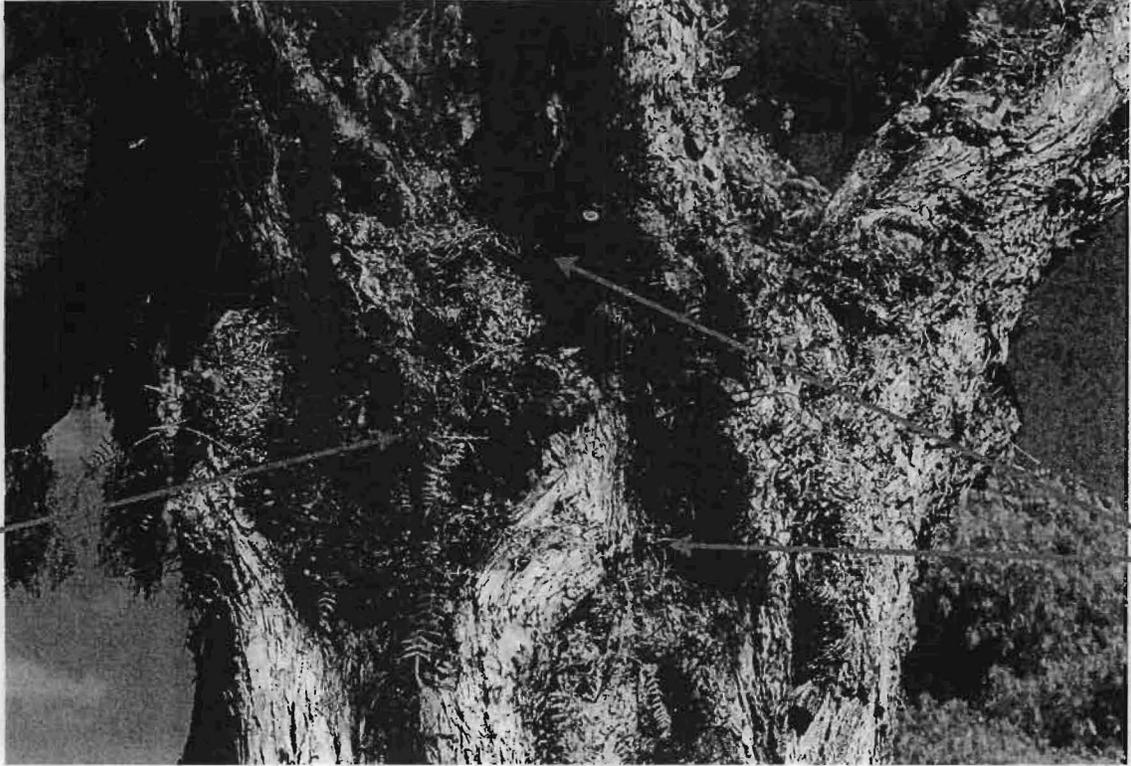
Tree #13, cavities and areas of decay in upper trunk

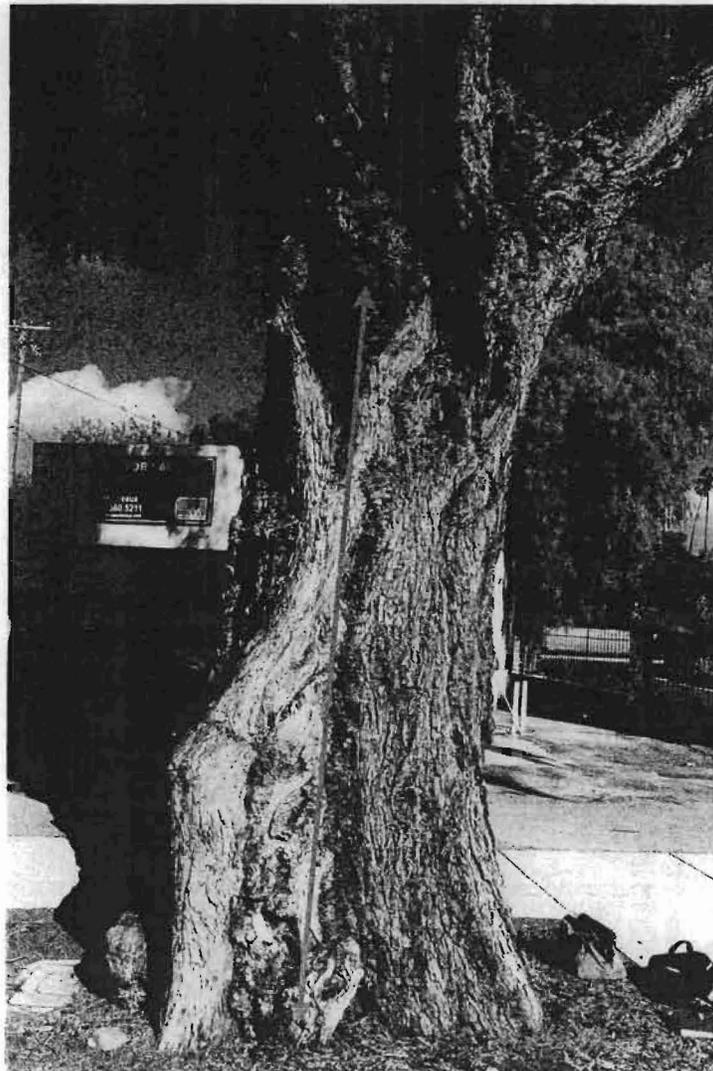
Tree #13, cavity estimated to run from  
ground level up trunk approx 11 feet

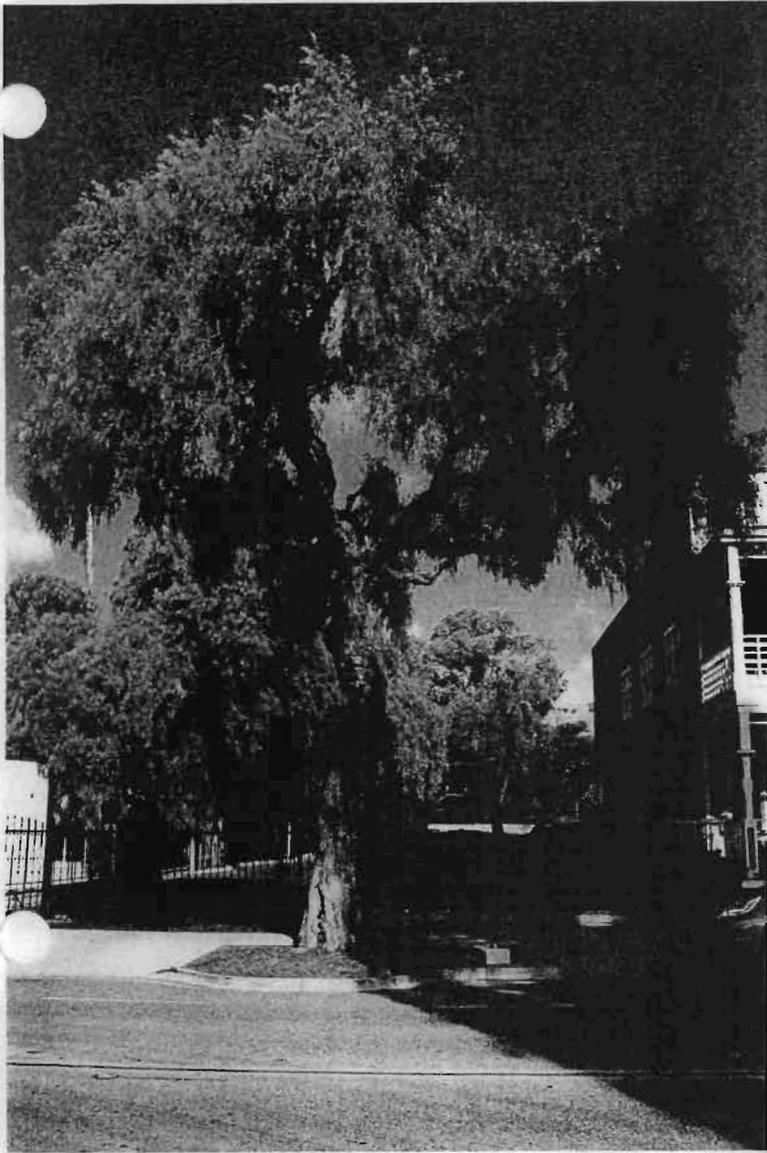
**Tree #14** is a large mature senescent tree. Although the tree appears to be healthy and displays good vigor with new shoot growth, it also contains severe structural defects that seriously compromise its structural stability. There is a 13" deep cavity on the SE side of the trunk approx. 6 feet above the ground, an 18" deep cavity on the west side at approx. 6 feet above the ground, a 27" deep cavity on the west side at 12 inches above the ground, a 25" deep cavity on the north side and the base of the trunk, and several other areas of potential decay and internal cavities were detected higher up in the trunk through sounding. The sum of defects describes a tree with serious stability problems in the trunk, scaffold and smaller branches in the crown.

Tree #14 contains severe structural defects such as cavities and decay that affect tree stability. I believe this tree poses a high risk for structural failure, and due to conditions of instability that cannot be reasonably mitigated the tree should be removed immediately. Should you decide to keep the tree in place I recommend root crown inspection and major heading of the canopy to reduce excess weight.

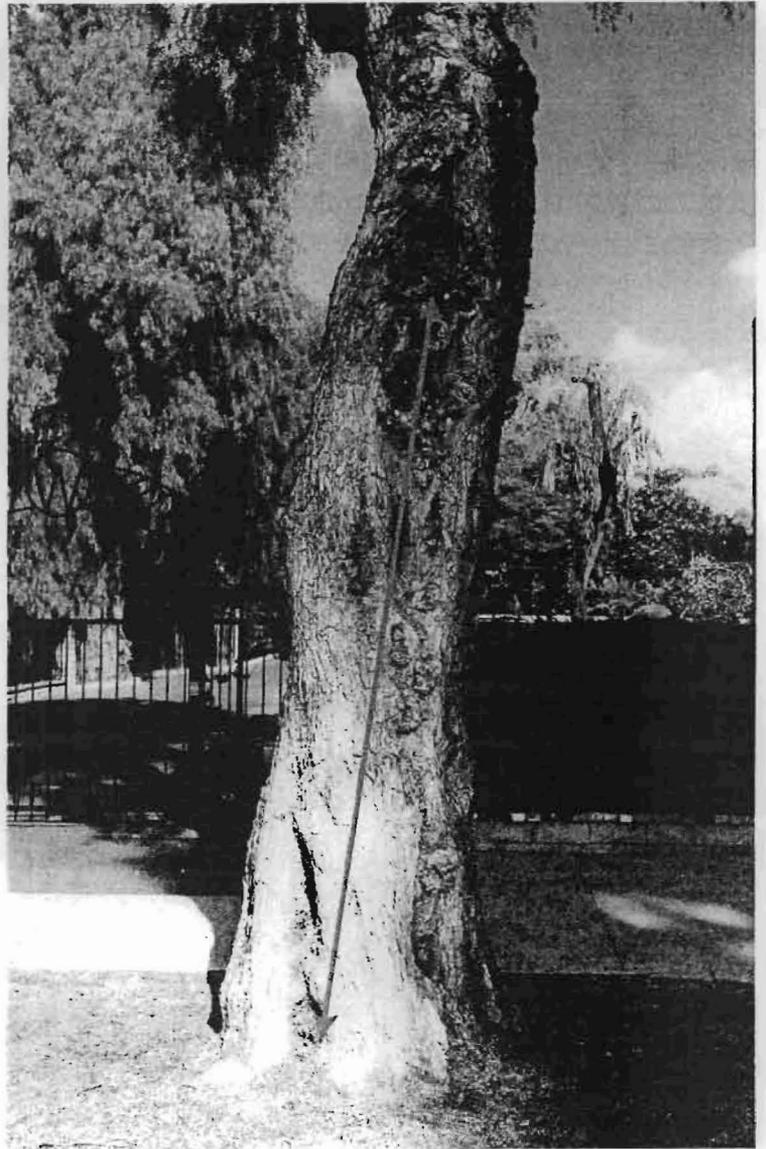
Tree #14, trunk cavity estimated to run from ground level up trunk 9 feet 272

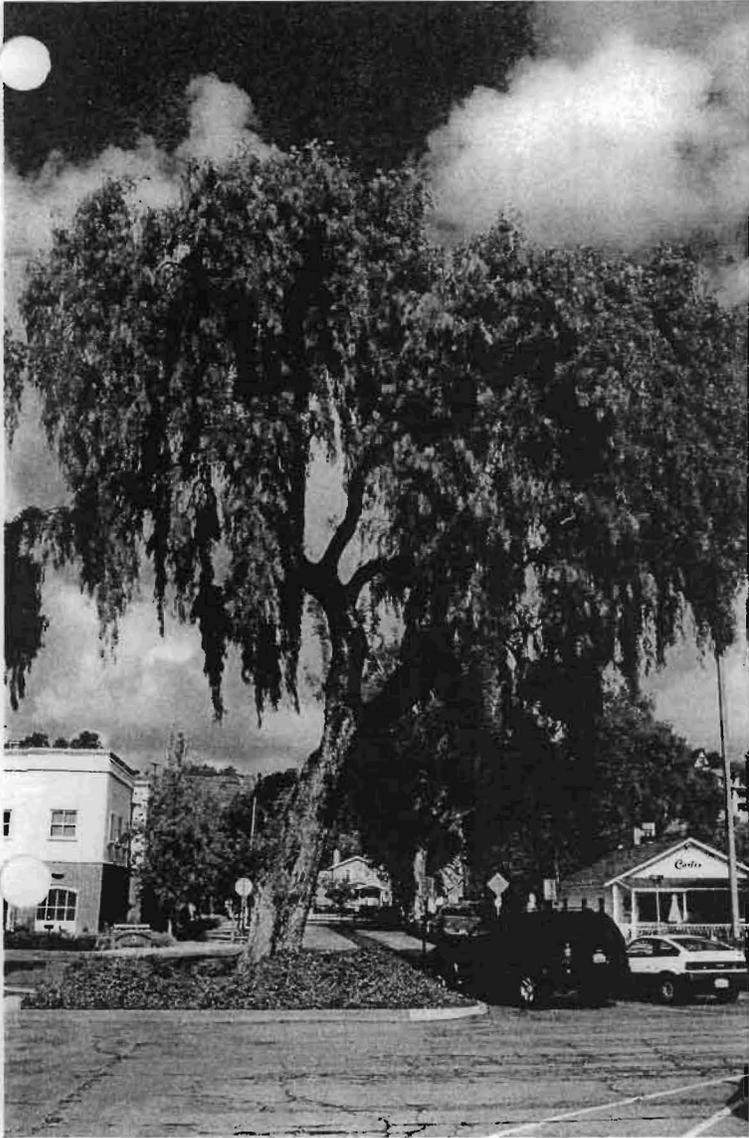
**Tree #30** is a 43" diameter historic veteran tree that is senescent. Although the tree appears to be healthy and displays good vigor with new shoot growth, it also contains severe structural defects that seriously compromise its structural stability. This tree has significant trunk lean to the east with the majority of its canopy on the east side of the trunk. The tree also displays a history of limb failure. There is a large cavity on the west side of the trunk at 7 feet above the ground, with additional signs of cavities and decay higher up on the trunk. A distinct hollow sound was detected on the west side of the trunk with a column of decay and a 26"-35" deep cavity running from the upper cavity to the ground. A cavity was also observed on the west of the tree at 12 inches above the ground.

Tree #30 contains severe structural defects such as cavities and decay that create severe problems relating to trunk stability. I believe this tree poses a high risk for structural failure and due to conditions of instability that cannot be reasonably mitigated the tree should be removed immediately. Should you decide to keep this tree in place, I strongly recommend that it be headed back significantly to reduce excess weight in the canopy and help reduce risk.

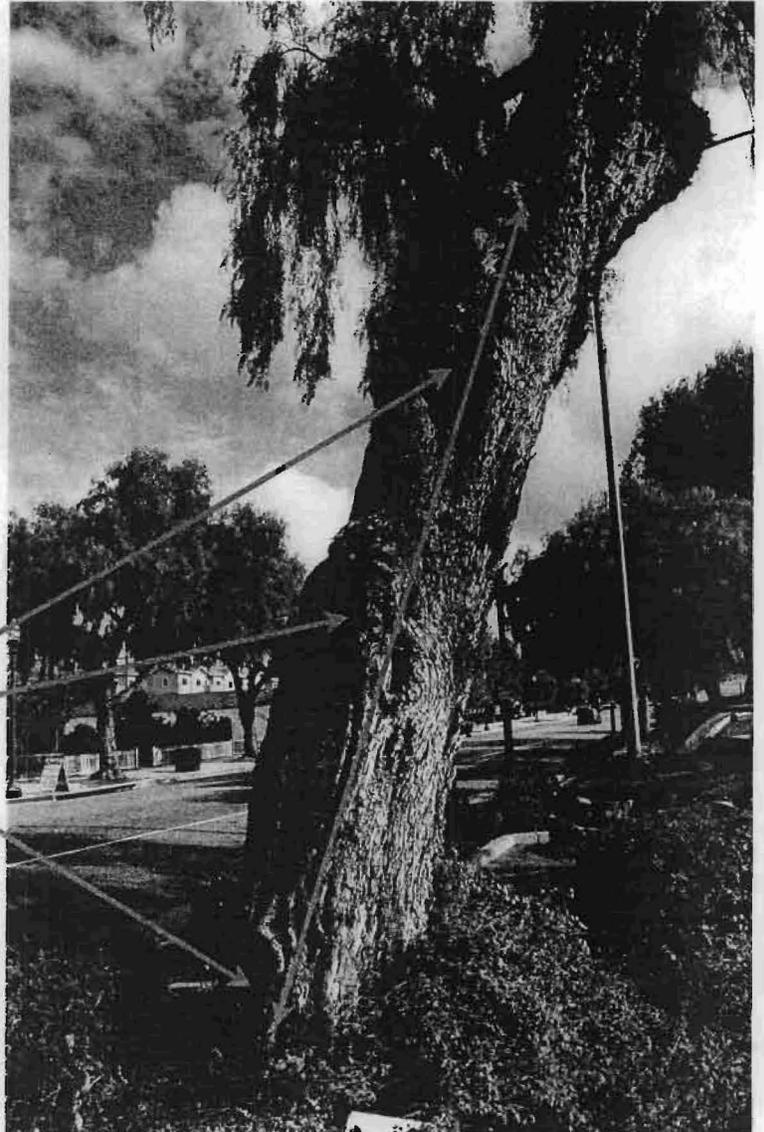
Tree #30, multiple cavities and areas of decay. Estimated 14 foot column of decay running up trunk from ground level

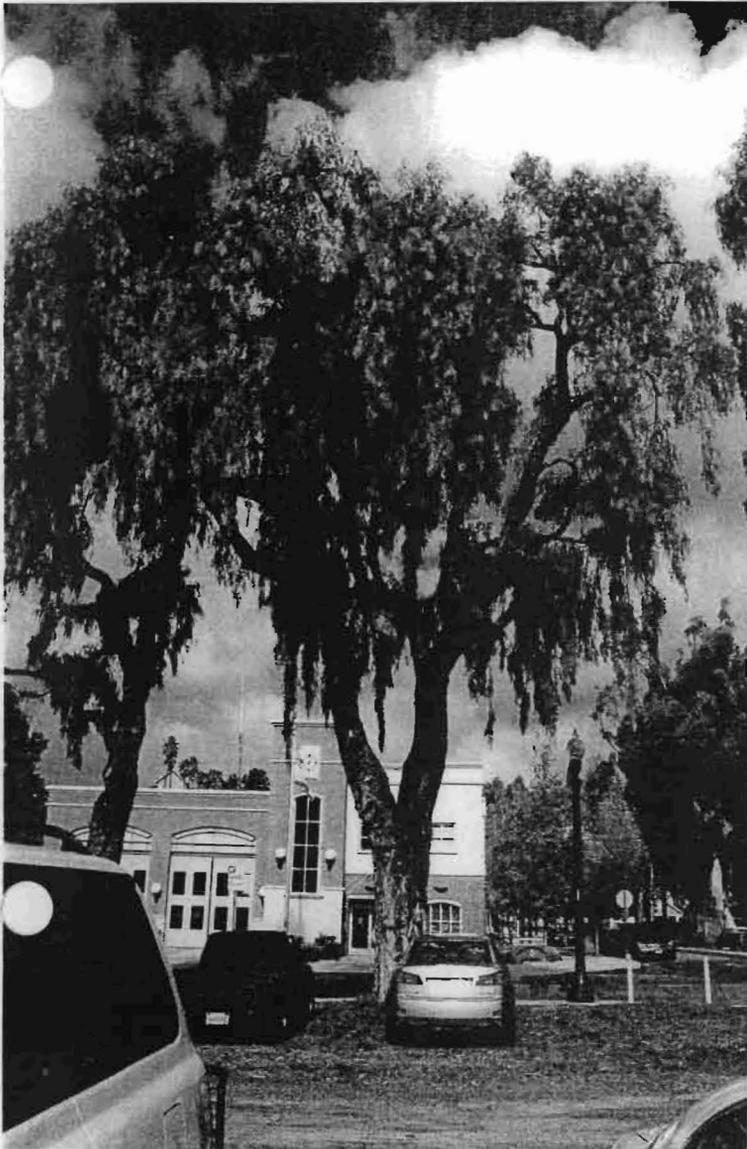
**Tree #31** is a 42" diameter historic veteran tree that is senescent. Although the tree appears to be healthy and displays good vigor with new shoot growth, it also contains severe structural defects that seriously compromise its structural stability. The tree has codominant stems. There are two beehives in the tree on the east side of the trunk at 8' and 14' above the ground. The presence of bees prevented a thorough inspection of the tree. The tree contains a 23" deep cavity in the trunk just below the lower beehive. It is very likely that the site of the two hives and opening below all converge into one large cavity.

Tree #31 contains severe structural defects such as cavities and decay creating serious problems and lack of stability in the main stem and large limbs. I believe this tree poses a high risk for structural failure and due to conditions of instability that cannot be reasonably mitigated the tree should be removed immediately. Should you decide to keep the tree in place, I strongly recommend that it be headed back significantly to reduce excess weight in the canopy and help reduce risk.

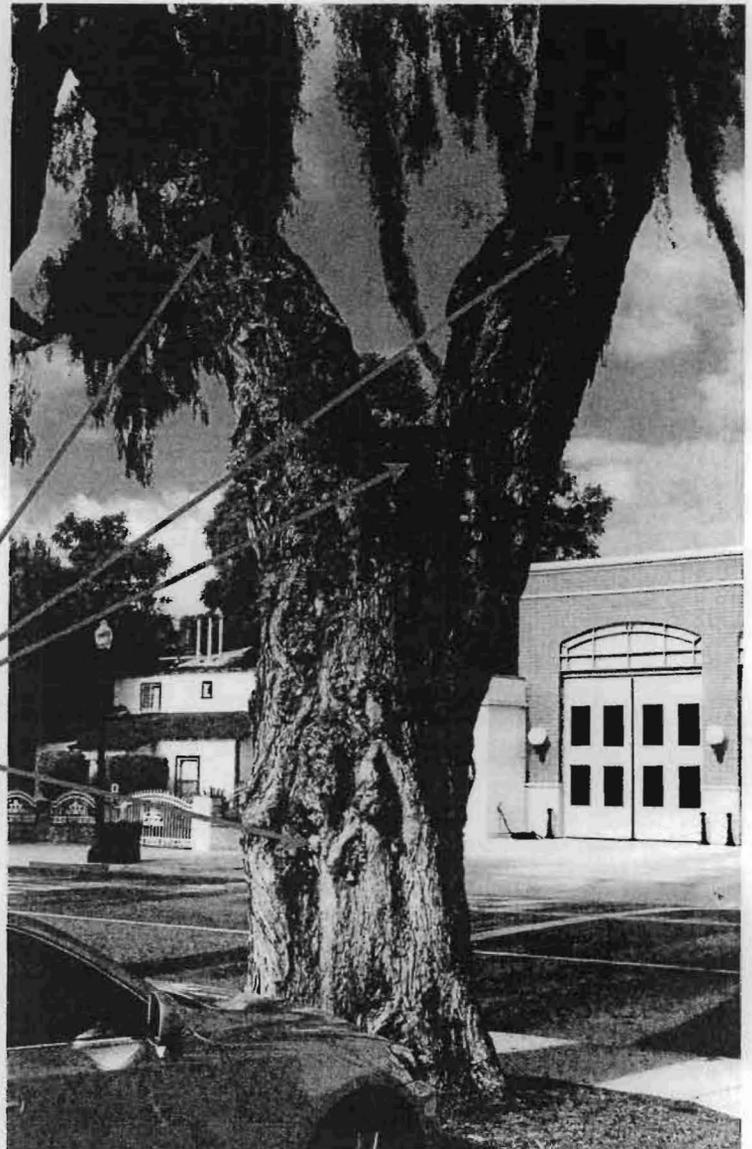
Tree #31, multiple cavities and areas of decay in main trunk and at union where trunk divides; weak crotch and main trunk

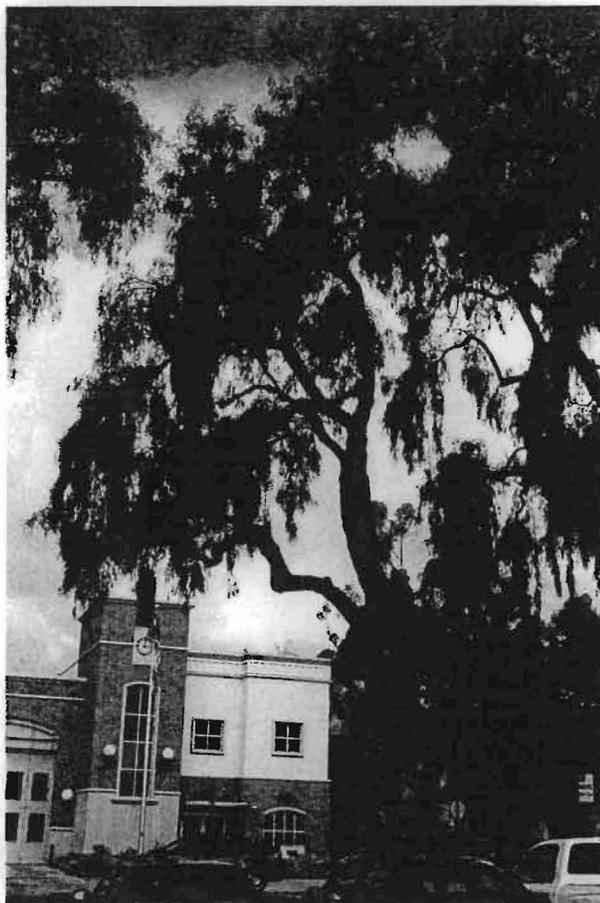
**Tree #32** is a 26" diameter historic tree that is senescent. The tree appears to be in good health but contains severe structural defects, and is one-sided with its entire canopy on the north side of the trunk. Tree #32 displays a history of limb failure on the south side. An 18" deep cavity was observed at the base of the trunk on the south side and another cavity was observed in the trunk at approx. 14-feet above the ground. This tree has serious problems relating to trunk stability.

Due to an extremely unbalanced crown, history of limb failure and deep cavities in the trunk I believe this tree poses a high risk for structural failure, and due to conditions of instability that cannot be reasonably mitigated the tree should be removed immediately. Should you decide to keep the tree in place, I strongly recommend that it be headed back significantly to reduce excess weight in the canopy and help reduce risk.

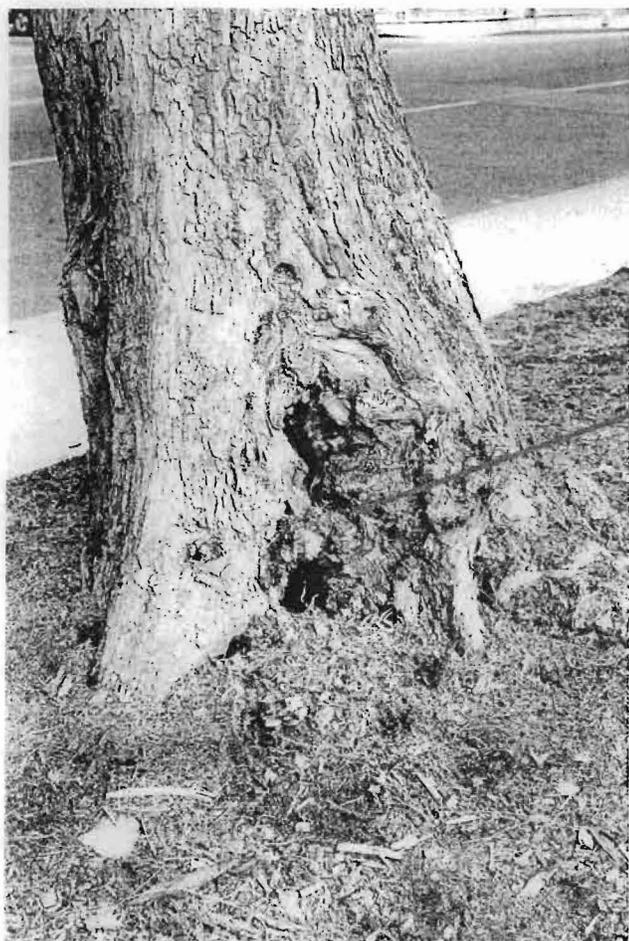
Tree #32, large cavity base of trunk

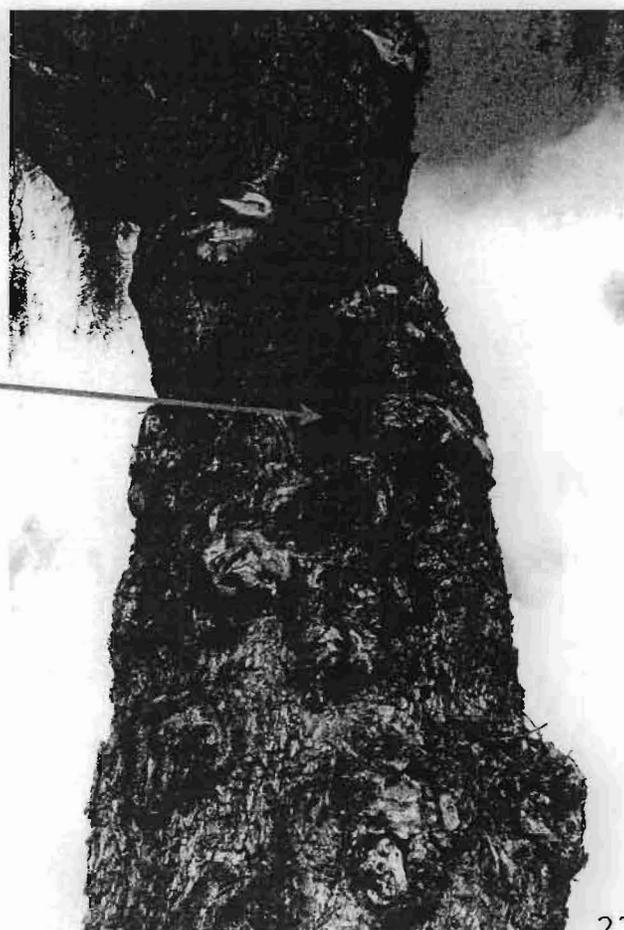
Tree #32. large cavity in upper trunk area

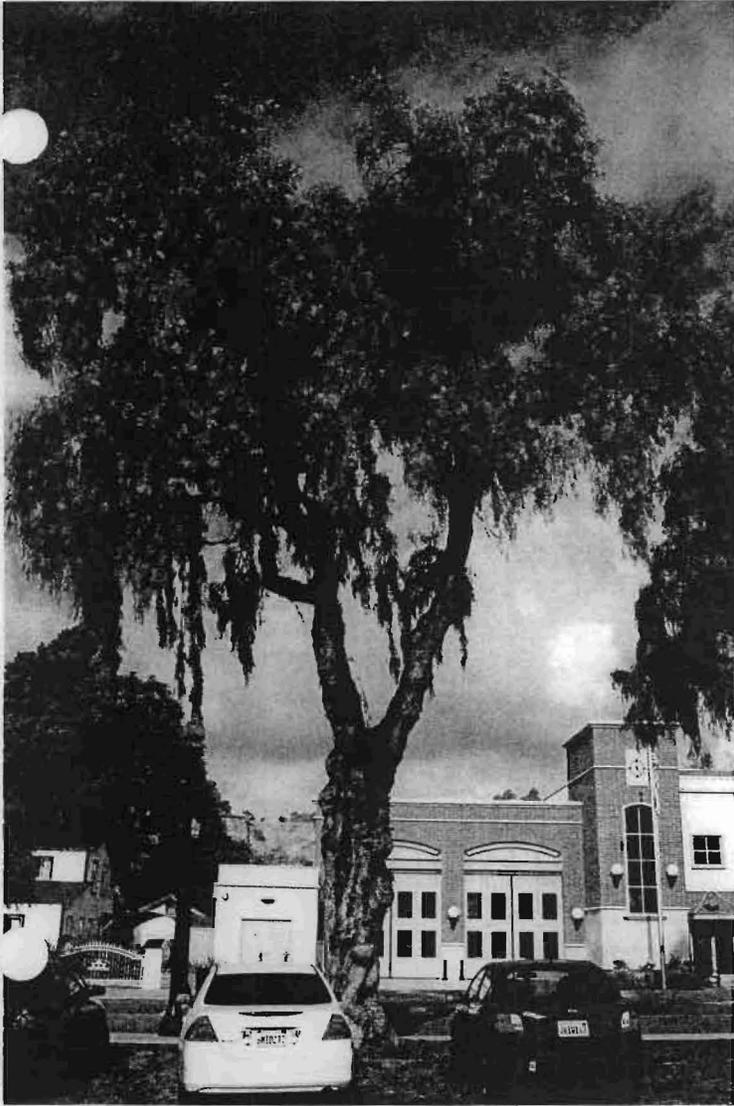
**Tree #33** is a 35" diameter historic tree that is senescent. Although the tree appears to be healthy and displays good vigor with new shoot growth, it also contains severe structural defects that seriously compromise its trunk stability. The tree has codominant stems with a deep sunken area at approx. 9 feet on the south side of the trunk, which is an indication of defects or internal decay. A distinct hollow sound was detected on the SW side of the trunk at 7 feet above the ground. The tree also contains a 20" deep cavity at the base of the trunk on the SW side, a 25" deep cavity on the north side at the base of the trunk, a 17" deep cavity on the SW side at 6 feet above the ground, and a large area of decay on the south side of the trunk at 9 feet above the ground. Compounding factor result in a tree that is considered seriously unstable.

Tree #33 contains severe structural defects such as cavities and decay. I believe this tree poses a high risk for structural failure and due to conditions of instability that cannot be reasonably mitigated the tree should be removed immediately. Should you decide to keep the tree in place, I strongly recommend that it be headed back significantly to reduce excess weight in the canopy and help reduce risk.

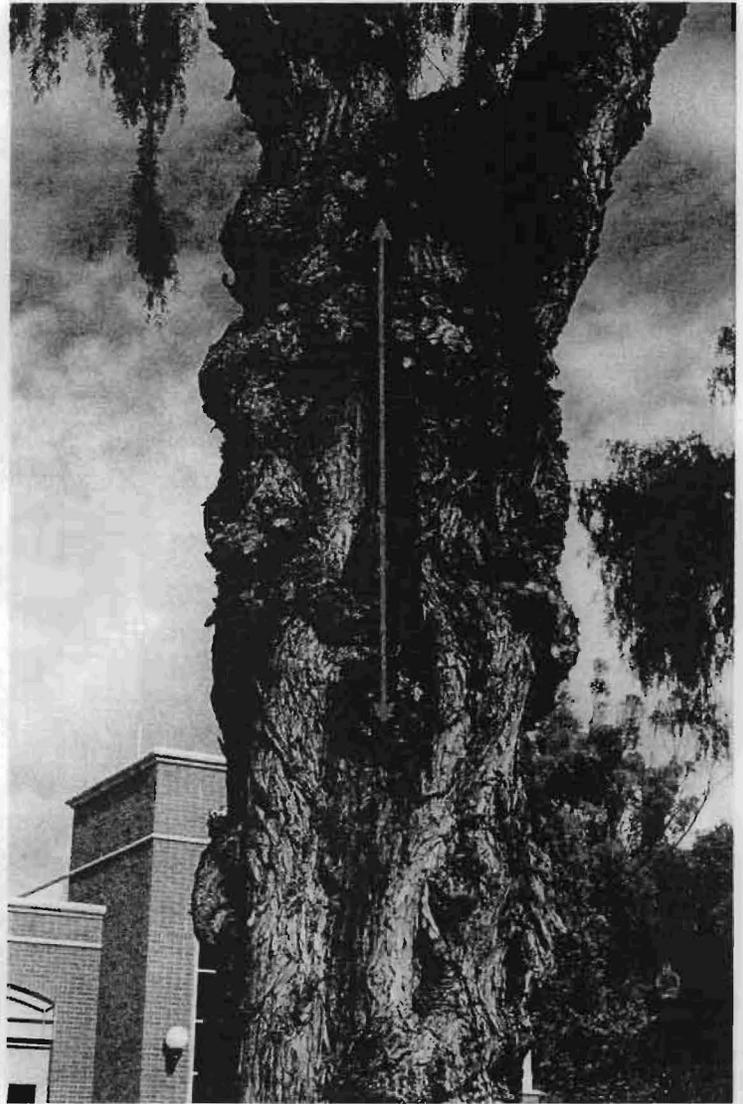
Tree #33, cavities in upper trunk area

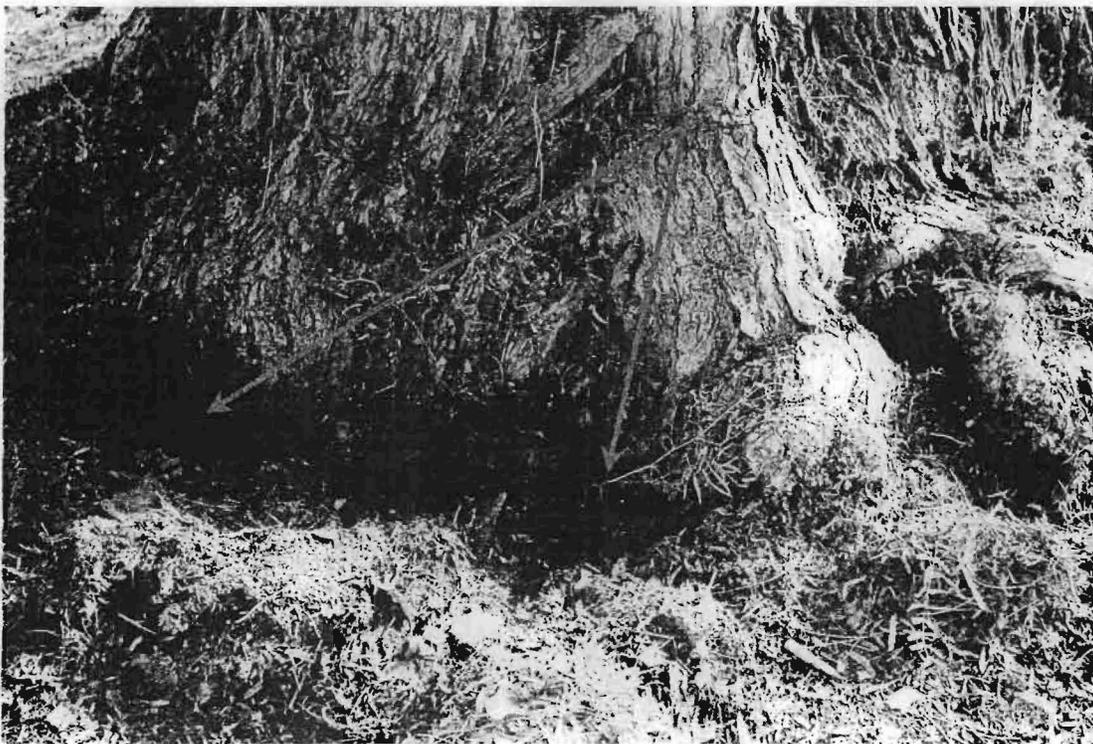
Tree #33, multiple cavities at base of trunk

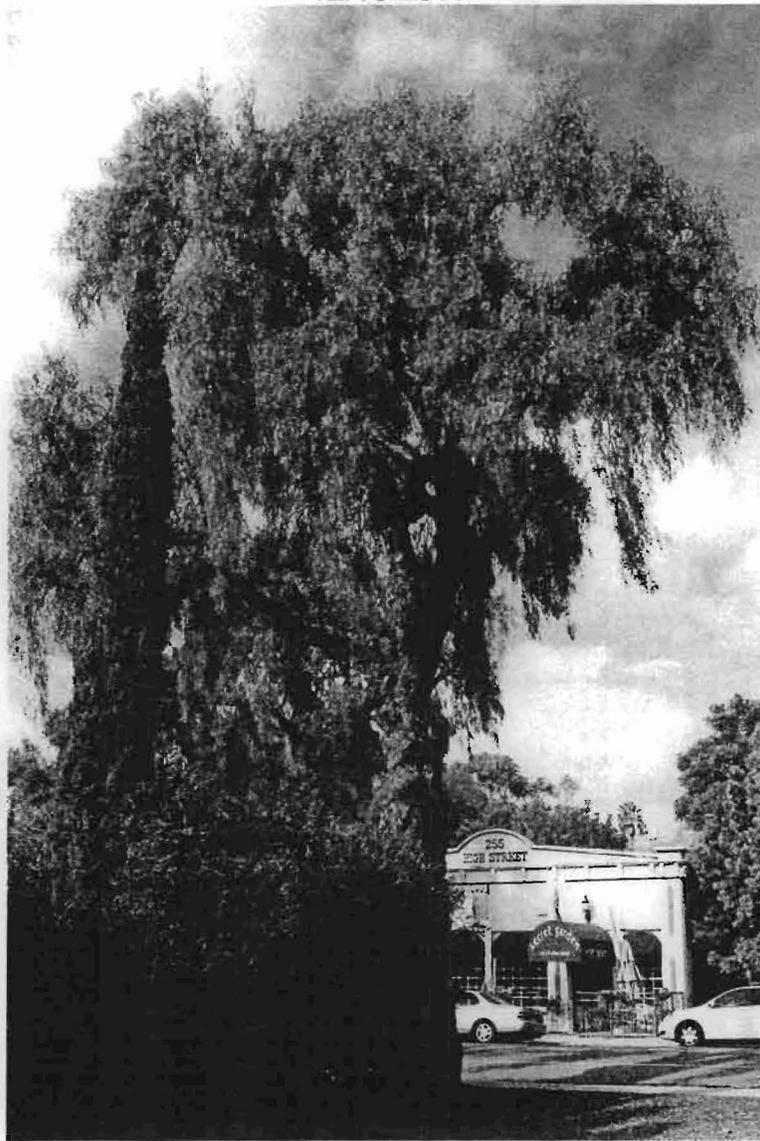
**Tree #35** is a 34" diameter historic veteran tree that is senescent. Although the tree appears to be healthy and displays good vigor with new shoot growth, it also contains severe structural defects that seriously compromise its structural stability in the main trunk. Several hollow decayed areas were detected in the lower trunk area through sounding. Cavities and decay were also observed in the lower south side of the trunk. There is a 37" deep cavity on the SW side of the tree at the base of the trunk, a 33" deep cavity on the east side at 1.5 feet above the ground, a 23" deep cavity 4 feet above the ground on the SE side of the trunk, and a large wound and cavity at 7 feet above the ground on the south side of the trunk.

Tree #35 contains severe structural defects such as cavities and decay that affect stability of the main trunk. I believe this tree poses a high risk for structural failure and due to conditions of instability that cannot be reasonably mitigated the tree should be removed immediately. Should you decide to keep the tree in place, I strongly recommend that it be headed back significantly to reduce excess weight in the canopy and help reduce risk.
