**MOORPARK CITY COUNCIL  
AGENDA REPORT**

**SUBJECT:** Consider Approval of the High Street Pepper Tree Recommendation Plan for the Removal of Fourteen (14) California Pepper Trees with a High Risk of Structural Failure

High Street Peppers  
12/15/2011

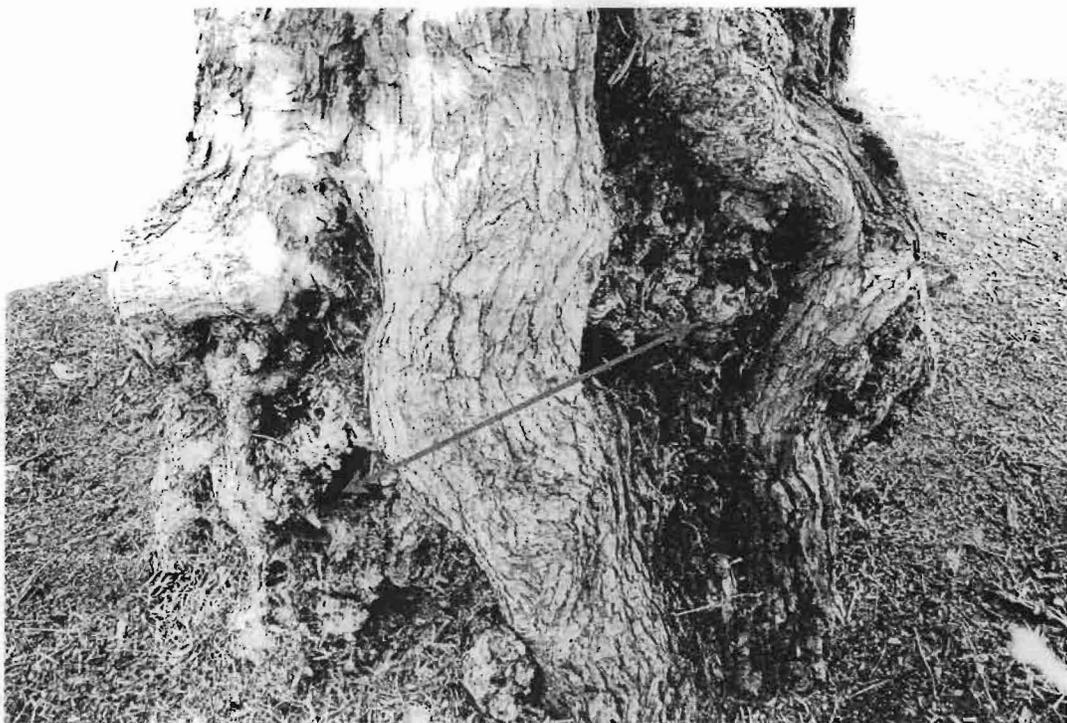
Tree #35, multiple cavities at base of trunk with signs of buckling

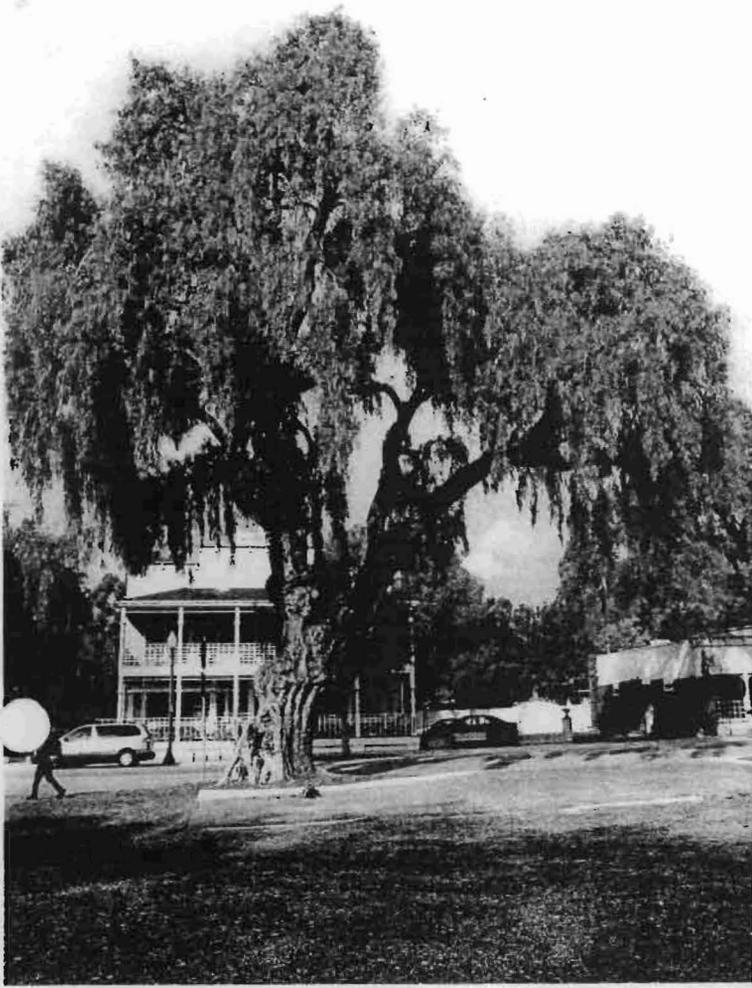
Tree #36

**Tree #36** is an historic senescent veteran tree and is probably the largest of the population. Based on foliage growth the tree appears to be fairly healthy but contains a huge cavity and area of decay on the south side of the trunk. There is a general hollow sound in the SW ½ of the trunk when sounded and general area of sound wood is very thin. Wood inside the large cavity is soft, punky and rotted, indicating the presence of wood decay fungi. Compounding data is indicative of a tree with severe problems relating to trunk stability.

Unfortunately the cavity and decay at the base of the trunk of tree #36 has advanced to the point that I believe the tree cannot reasonably support itself and poses a high risk for structural failure. I believe this tree poses a high risk for structural failure and due to conditions of instability that cannot be reasonably mitigated the tree should be removed immediately. Should you decide to keep the tree in place, I strongly recommend that it be headed back significantly to reduce excess weight in the canopy and help reduce risk.

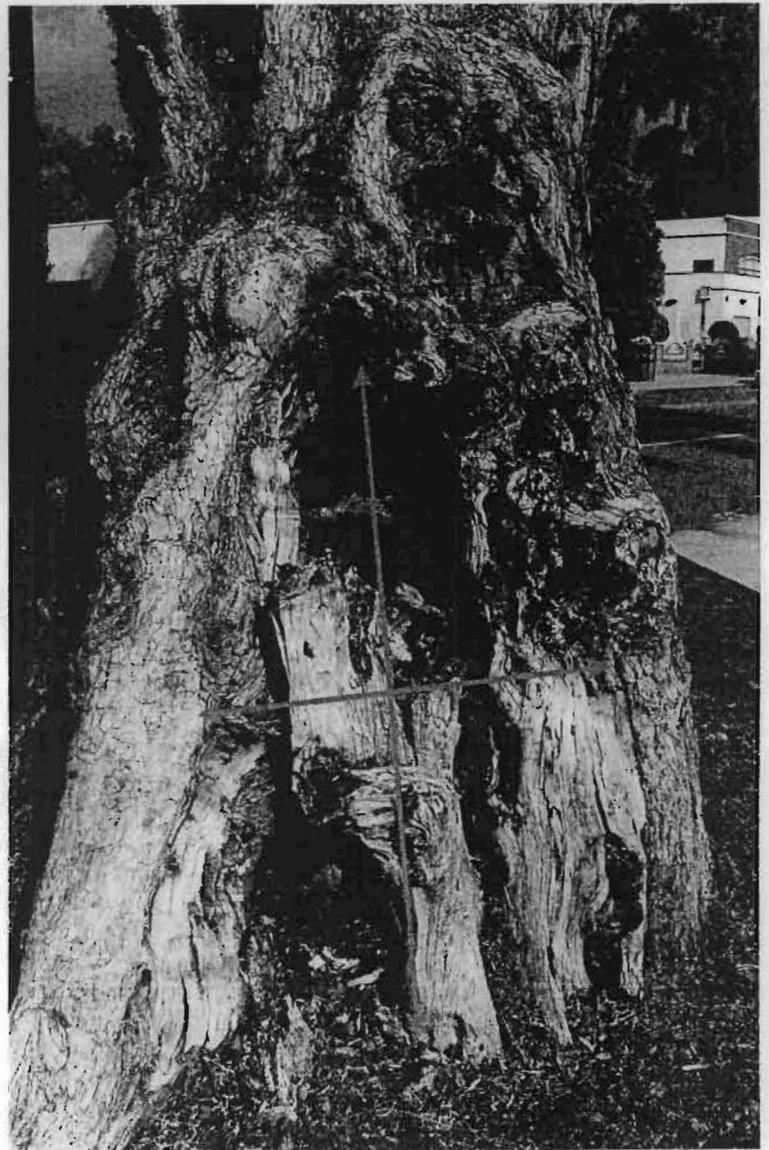
Tree #36, extremely large trunk cavity with areas of very thin shell walls 278

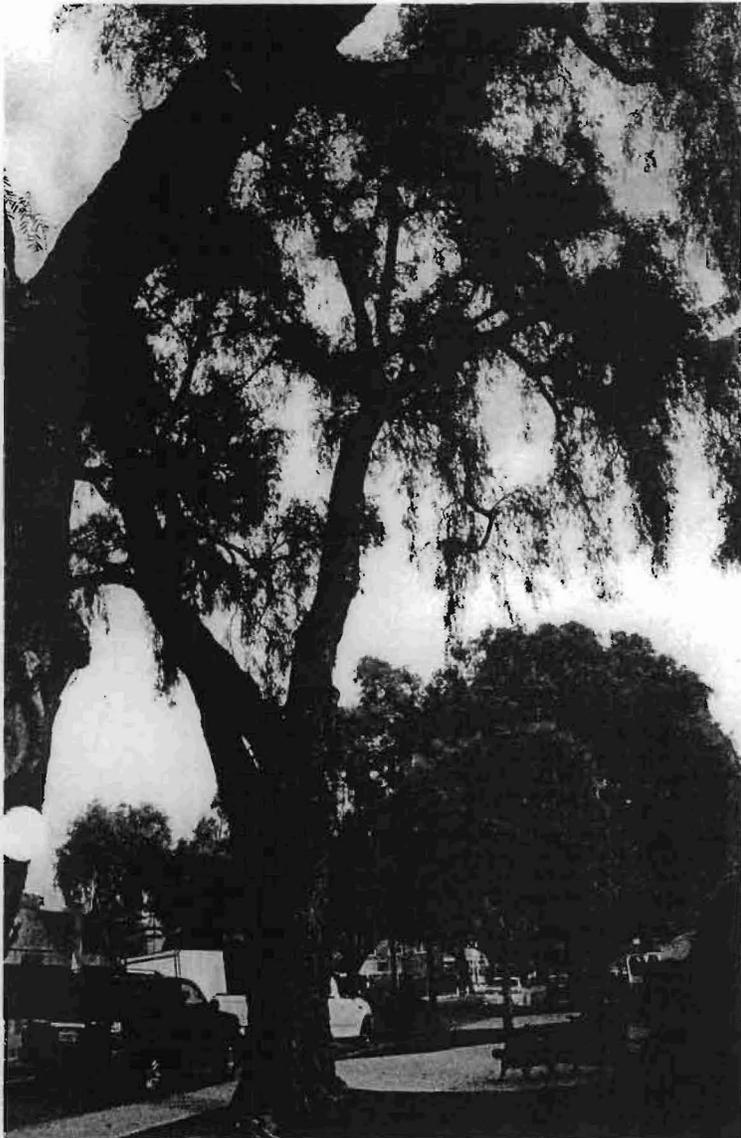
**Tree #46** is a 41" diameter historic veteran tree that is also senescent. Although the tree appears to be healthy and displays good vigor with new shoot growth, it also contains severe structural defects that seriously compromise stability in the trunk and large scaffold limbs. There is a beehive in the south lateral limb at approx. 15 feet up in the tree. Multiple small cavities and pockets of decay observed in both the large N & S lateral limbs directly over High street. The tree also contains a large cavity on the east side of the trunk at 5.5 feet above the ground near the point of connection of the two large codominant scaffold limbs. There is also a cavity on the south side of the trunk with a column of decay that likely runs all the way to ground level also running upward into the north lateral limb.

Tree #46 contains severe structural defects such as cavities and decay. I believe this tree poses a high risk for structural failure and due to conditions of instability that cannot be reasonably mitigated the tree should be removed immediately. Should you decide to keep the tree in place, I strongly recommend that it be headed back significantly (not less than 50%) to reduce excess weight in the canopy and help reduce risk. This tree has serious stability problems in the main trunk and large limbs and is at high risk for failure.

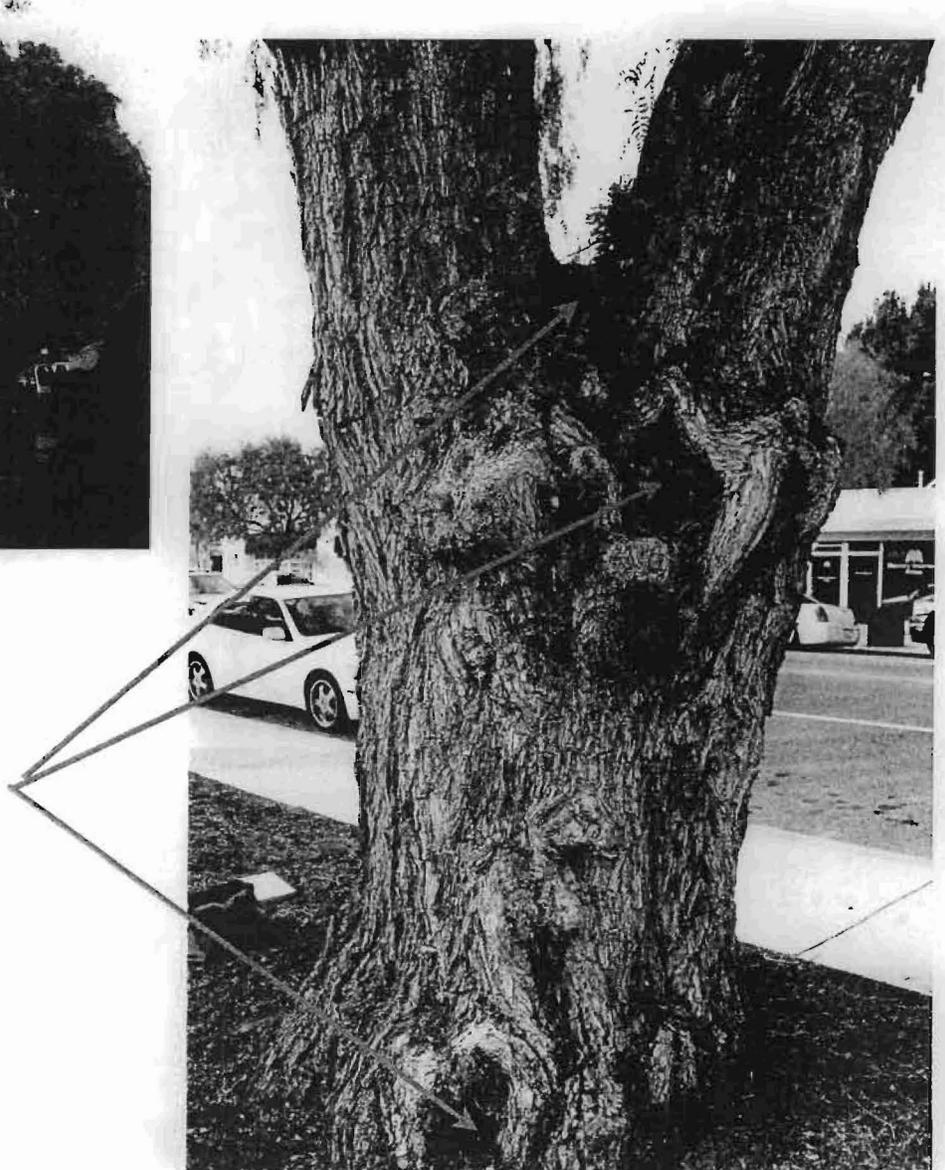
Tree #46, multiple deep cavities and areas of decay, including hollow at crotch 279

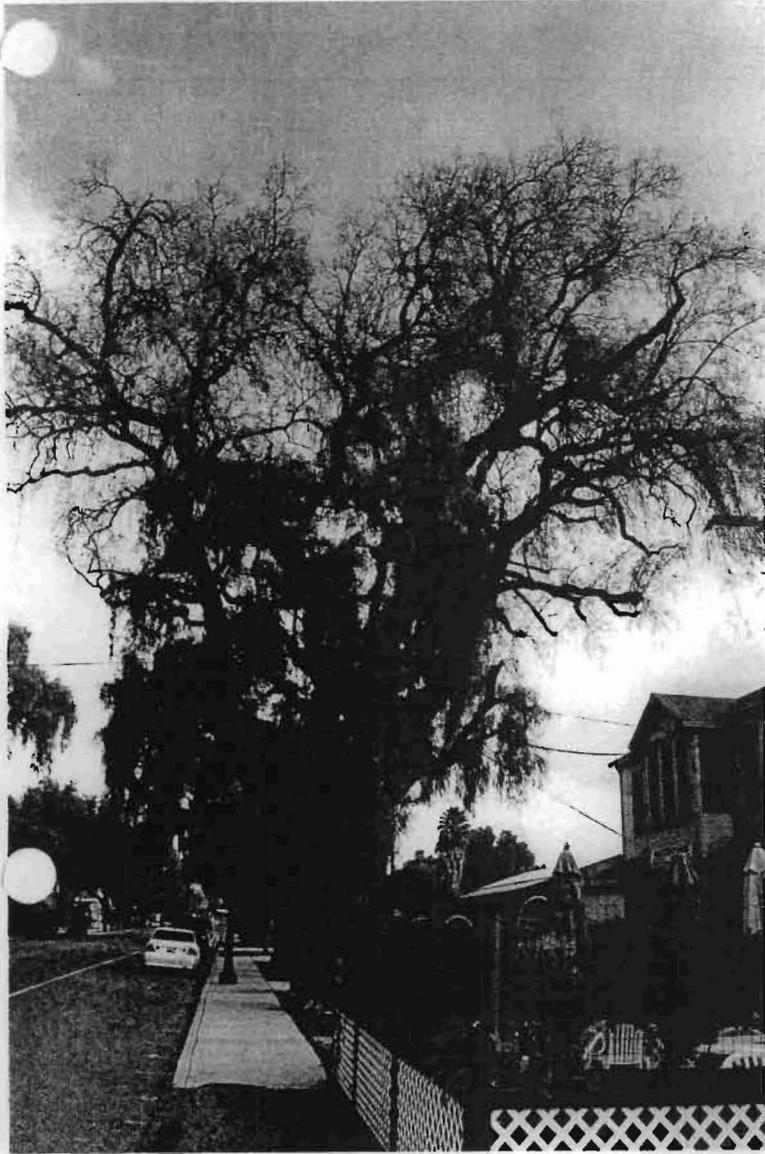
**Tree #49** has all but failed due to oak root rot disease and should be removed as soon as possible to eliminate the risk of unexpected structural failure. Root rot seriously affects the integrity of root and tree stability.

Tree #49 immediately as it is failing due to incurable root rot disease.

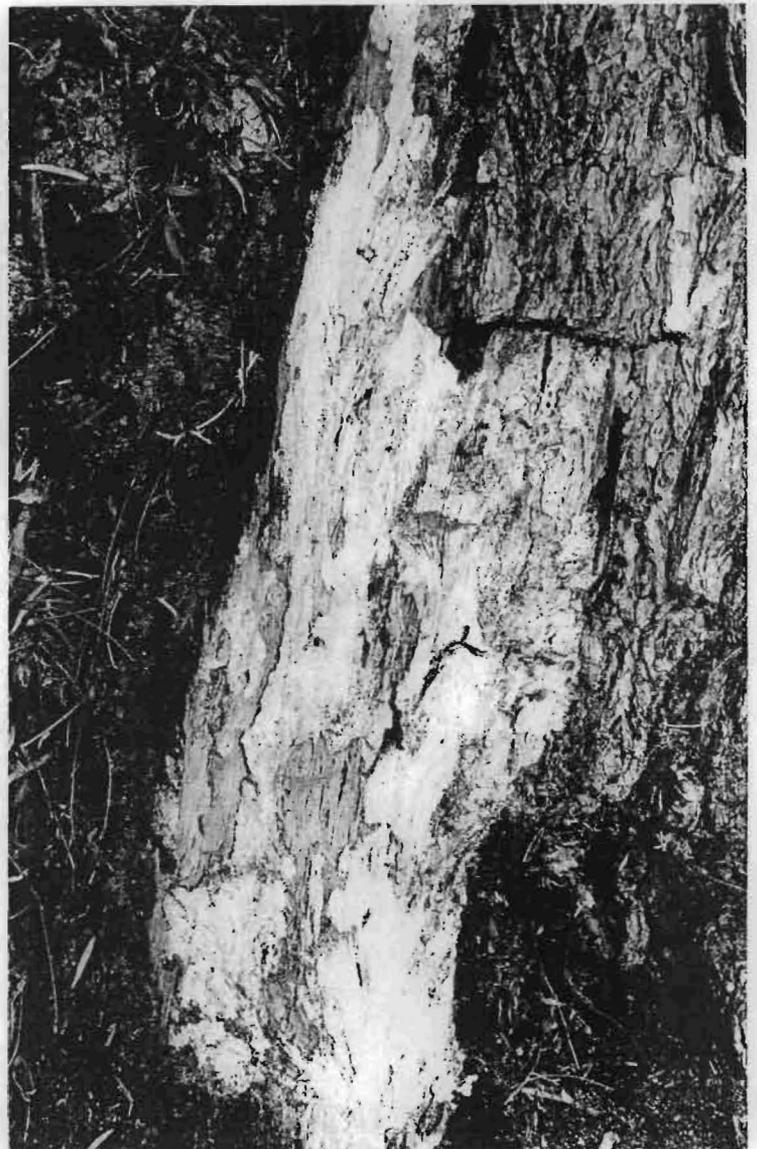
Tree #49, visually diagnostic signs of  
*Armillaria mellea* root rot disease 280
