**MOORPARK CITY COUNCIL
AGENDA REPORT**

SUBJECT: Consider the California Pepper Trees Maintenance Plan and Final Environmental Impact Report

California Pepper Grove – High Street Moorpark, California

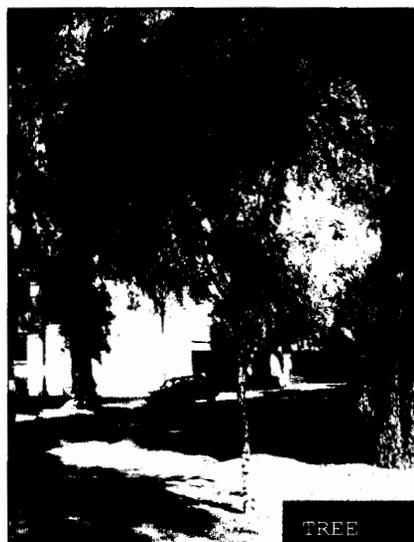
Tag/site #48 This 4-inch diameter tree is growing in a typically unrestricted growing space with a monolithic sidewalk and curb/gutter. The tree is becoming established. Monitor the tree's progress; provide supplemental irrigation as needed; provide routine pruning techniques as needed, direct the development of temporary major scaffold limbs on an east/west axis, thin foliage on heavily laden limbs to avoid excessive strain, drooping, and possible breakage, avoid heading-back terminal ends and promote an upward growing canopy architecture, avoid over pruning the tree (remove up to or less than but no more than 20 percent live foliage).

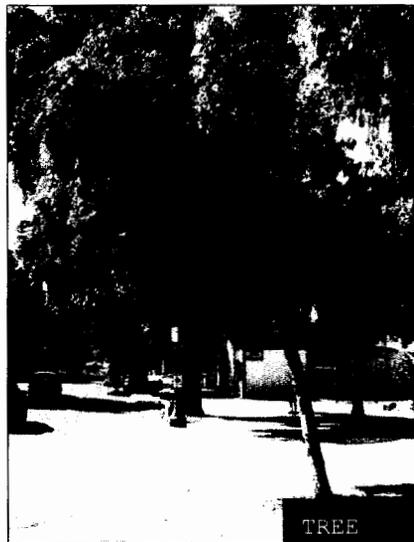
Tag/site #24 This 7-inch diameter tree is growing in a typically restricted growing space. The tree is established and requires routine maintenance treatments. The tree has developed with a pronounced lean to the south (toward High Street) resulting in disproportionate encroachment of the canopy into the roadway. Monitor the tree's progress; provide supplemental irrigation during periods of extended drought, as needed; provide crown reconstruction pruning techniques to counter canopy encroachment; provide routine pruning techniques as needed, direct the development of temporary major scaffold limbs on an east/west axis, prune to thin foliage on heavily laden limbs to avoid excessive strain, drooping, and possible breakage, avoid heading-back terminal ends and promote an upward growing canopy architecture, avoid over pruning the tree if possible but take necessary steps to redirect canopy development while maintaining tree health.

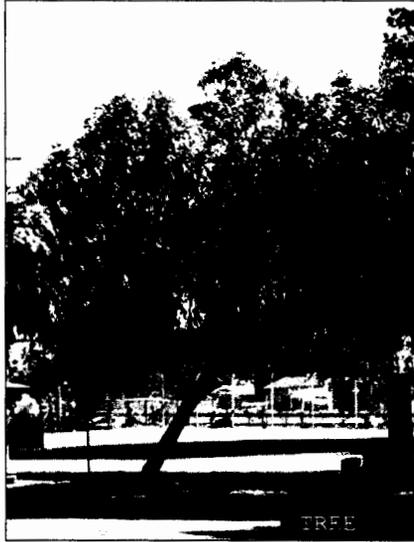
Tag/site #50 This 10-inch diameter tree is growing in an atypical growing space – it is set back about 2' from the monolithic boardwalk/sidewalk and a gravel/asphalt parking lot exists about 3' behind the tree; its canopy is restricted by an adjacent tree growing 25 feet to the west. The tree is established and requires routine maintenance treatments. The tree has developed with a pronounced lean to the west (toward tree tagged #51) resulting in an inclusion of the two canopies. Neither tree is subordinated at this time. Monitor the tree's progress; provide supplemental irrigation as needed; provide crown reconstruction pruning techniques to counter canopy encroachment, provide routine pruning techniques as needed, direct the development of temporary major scaffold limbs on an east/west axis, prune to thin foliage on heavily laden limbs to avoid excessive strain, drooping, and possible breakage, avoid heading-back terminal ends and promote an upward growing canopy architecture, avoid over pruning the tree if possible but take necessary steps to redirect canopy development while maintaining tree health.

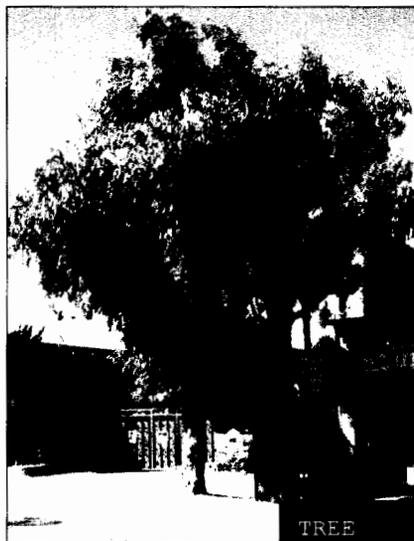
Tag/site #2 This 21-inch diameter tree is growing in a typically restricted growing space with a park-style bench located about 10 feet north of the planting site. The tree has a canopy that extends about 35 feet high and 25 feet wide. One or more of the primary scaffold limbs are oriented toward the east and originate from the main stem about 8 feet up from grade. Monitor the tree's stability on a routine basis (at least annually and at times of inclement weather); provide crown reconstruction pruning techniques to improve scaffold branch attachment and arrangement, provide routine pruning techniques as needed, prune to provide adequate clearance for vehicular traffic on High Street and

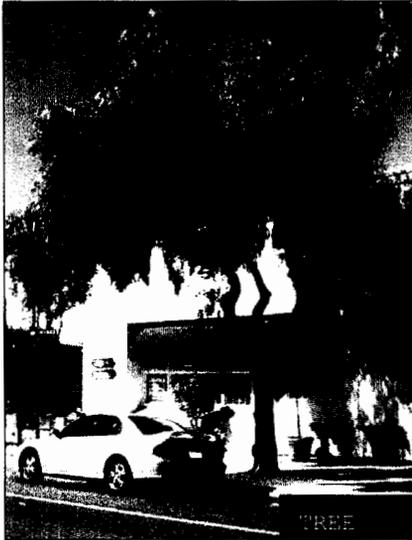
Tag/site #5 This 14-inch diameter tree is growing in a typically restricted growing space. The tree has a canopy that extends about 35 feet high and as wide. The tree was somewhat over pruned previously and the main scaffold limbs originate low in the canopy architecture; the lowest major scaffold limb bifurcates from the stem about 6 feet up from grade and the canopy is raised high and distributed among four roughly co-dominant scaffolds that are oriented on an east/west axis. Monitor the tree's stability on a routine basis; provide crown reconstruction pruning to promote branch develop lower in the canopy, provide routine pruning techniques as needed, prune to maintain adequate clearance for vehicular traffic on High Street and pedestrian traffic along the sidewalk, prune to thin foliage on heavily laden limbs to avoid excessive strain, drooping, and possible breakage, avoid heading-back terminal ends and promote an upward growing canopy architecture, avoid over pruning the tree if possible but take necessary steps to redirect canopy development while maintaining tree health.

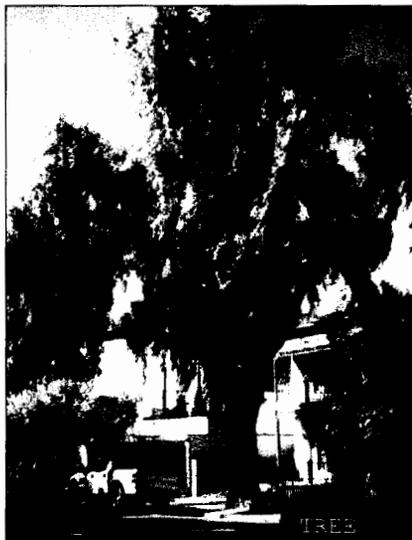
Tag/site #8 This 38-inch diameter tree is growing in a typically restricted growing space with a park-style bench located about 10 feet northwest of the planting site. The tree has a canopy that extends about 50 feet high and 60 feet wide. Initial stem bifurcation occurs about 10 feet up, progressive branching of primary and secondary scaffold limbs occurs throughout the canopy promoting a well distributed branch architecture. Several of the scaffold limbs are long and horizontal and tend to be heavily loaded toward branch ends. Monitor the tree's stability on a routine basis; provide crown reconstruction pruning techniques along the long horizontal limbs to promote branch development and architectural structure closer toward the main stem, provide routine pruning

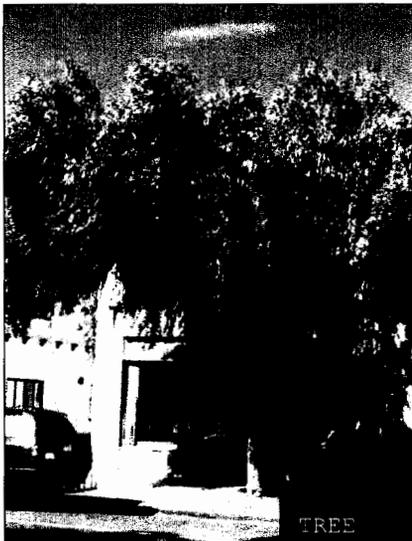
Tag/site #10 This 12-inch diameter tree is growing in a typically restricted growing space. It does not have a number tag attached to the trunk at this time. The tree has a canopy that extends about 25 feet high and 35 feet wide. Multiple primary scaffold limbs originate from the main stem about 8 feet up from grade with a horizontal orientation. Monitor the tree's stability on a routine basis; provide crown reconstruction pruning techniques to improve scaffold branch attachment and arrangement, provide routine pruning techniques as needed, prune to provide adequate clearance for vehicular traffic on High Street and pedestrian traffic along the sidewalk, prune to thin foliage on heavily laden limbs to avoid excessive strain, drooping, and possible breakage, avoid heading-back terminal ends and promote an upward growing canopy architecture, avoid over pruning the tree if possible but take necessary steps to redirect canopy development while maintaining tree health.

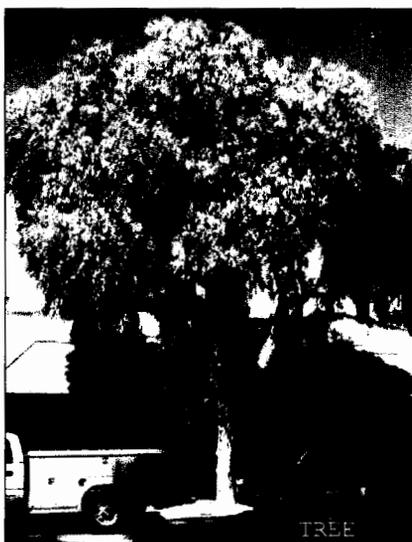
Tag/site #11 This 15-inch diameter tree is growing in a typically restricted growing space. It does not have a number tag attached to the trunk at this time. The tree has a canopy that extends about 35 feet high and as wide. Initial stem bifurcation occurs about 8 feet up, progressive branching of primary and secondary scaffold limbs occurs throughout the canopy promoting a well distributed branch architecture. Monitor the tree's stability on a routine basis; provide routine pruning

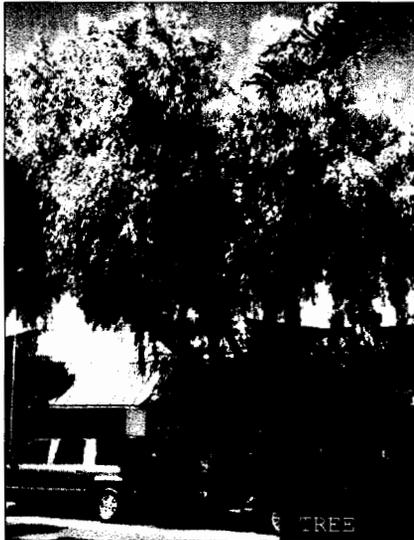
Tag/site #12 This 18-inch diameter tree is growing in a typically restricted growing space. It does not have a number tag attached to the trunk at this time. The tree has a canopy that extends about 35 feet high and 40 feet wide. Initial stem bifurcation occurs about 6 feet up, progressive branching of primary scaffold limbs with sharp-angled crotches occurs throughout the canopy. Monitor the tree's stability on a routine basis with particular emphasis on the attachment of limbs with sharp-angled crotches; provide crown reconstruction pruning techniques to improve scaffold branch attachment and arrangement, provide routine pruning techniques as needed, prune to maintain adequate clearance for vehicular traffic on High Street and pedestrian traffic along the sidewalk, prune to thin foliage on heavily laden limbs to avoid excessive strain, drooping, and possible breakage, avoid heading-back terminal ends and promote an upward growing canopy architecture, avoid over pruning the tree if possible but take necessary steps to redirect canopy development while maintaining tree health.

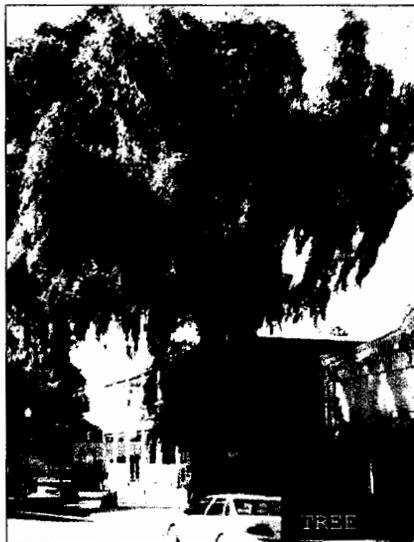
Tag/site #16 This 39-inch diameter tree is growing in a modified typically restricted growing space – the planter pops out into the roadway a distance of about 4 feet. The tree has a canopy that extends about 50 feet high and 60 feet wide. Initial stem bifurcation occurs about 20 feet up, progressive branching of primary and secondary scaffold limbs occurs throughout the canopy producing an especially high canopy architecture. Several of the scaffold limbs are long and horizontal and tend to be heavily loaded toward branch ends. Monitor the tree's stability on a routine basis; provide crown reconstruction pruning techniques along the long horizontal limbs to promote branch development and architectural structure closer toward the main stem, provide routine pruning techniques as needed, prune to maintain adequate clearance for vehicular traffic on High Street and pedestrian traffic along the sidewalk but, over time, develop well placed new sprouts to extend canopy architecture lower on the stem, prune to thin foliage on heavily laden limbs to avoid excessive strain, drooping, and possible breakage, routinely reduce horizontal canopy expansion by selectively cutting back terminal ends to appropriate-sized and well-placed lateral branches, avoid over pruning the tree (remove up to or less than but no more than 20 percent of the live foliage).

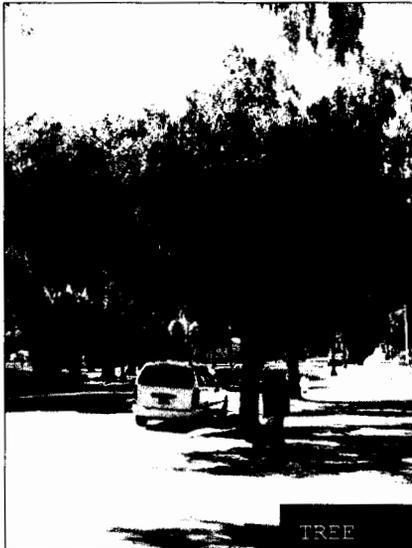
Tag/site #20 This 17-inch diameter tree is growing in a typically restricted growing space. The tree has a canopy that extends about 25 feet high and as wide. Initial stem bifurcation occurs about 8 feet up, progressive branching of primary and secondary scaffold limbs occurs throughout the canopy promoting a well distributed branch architecture. Removal of one or more low horizontal limbs may improve the canopy form and reduce long-term pedestrian clearance requirements. Monitor the tree's stability on a routine basis; provide routine pruning techniques as needed, prune to provide adequate clearance for vehicular traffic on High Street and pedestrian traffic long the sidewalk, prune to thin foliage on heavily laden limbs to avoid excessive strain, drooping, and possible breakage, avoid heading-back terminal ends and promote an upward growing canopy architecture, avoid over pruning the tree (remove up to or less than but no more than 20 percent of the live foliage).

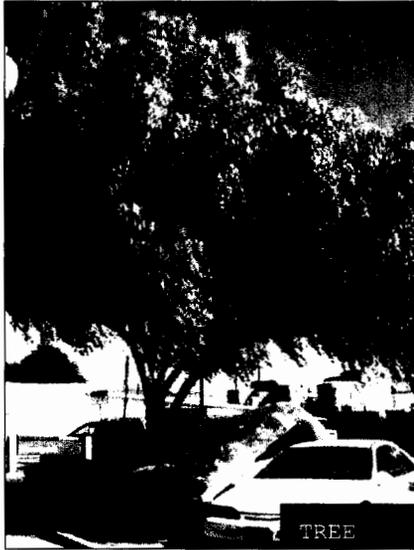
Tag/site #27 This 15-inch diameter tree is growing in an atypical growing space that is 15 feet deep but only 5 feet wide. The tree has developed with a pronounced lean to the south; its canopy extends about 20 feet high and 25 feet wide. Initial stem bifurcation occurs about 4 feet up with multiple primary scaffold limbs originating with narrow crotch angles, low on the main stem, and extending along a low, horizontal angle. Monitor the tree's stability on a routine basis, especially sections that extend over (and therefore tend to threaten) the vicinity of the parking lot; provide crown reconstruction pruning techniques to improve scaffold branch attachment and arrangement, provide routine pruning techniques as needed, prune to provide adequate clearance for vehicular and pedestrian traffic, prune to thin foliage on heavily laden limbs to avoid excessive strain, drooping, and possible breakage, avoid heading-back terminal ends and promote an upward growing canopy architecture, avoid over pruning the tree if possible but take necessary steps to redirect canopy development while maintaining tree health.

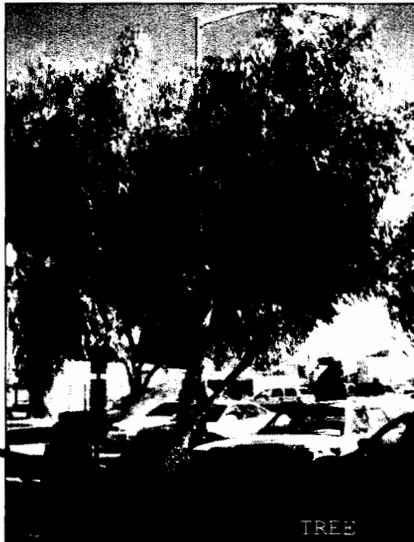
Tag/site #28 This 11-inch diameter tree is growing in an atypical growing space that is 9 feet wide but the trunk is only 1 foot west and 2 feet south of pavement edges. Large surface roots (6-inches in diameter and 4-inches in diameter – see detail photo) have been cut on the north side, behind the direction of the tree's lean, to avert encroachment with adjacent pavement. This treatment tends to destabilize the tree. The tree has one low horizontal scaffold limb extending to the south; its canopy, 20-foot high and as wide, is otherwise symmetrical. Monitor the tree's stability on a routine basis, especially sections that extend over (and therefore tend to threaten) the vicinity of the parking lot; provide pruning treatments to remove the low branch and

improve the branch distribution, provide routine pruning techniques as needed, prune to provide adequate clearance for vehicular and pedestrian traffic, prune to thin foliage on heavily laden limbs to avoid excessive strain, drooping, and possible breakage, avoid heading-back terminal ends and promote an upward growing canopy architecture, avoid over pruning the tree if possible but take necessary steps to redirect canopy development while maintaining tree health. When the opportunity arises to replace the tree the new specimen should be centered in the growing space.

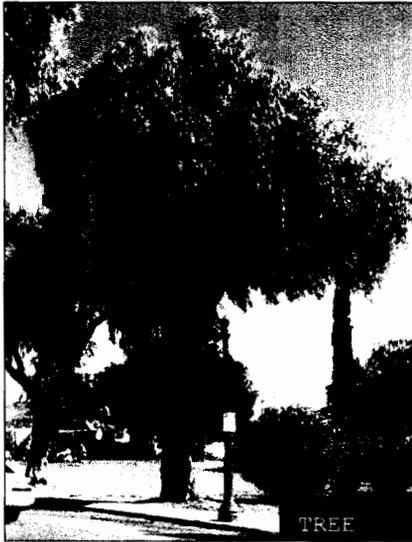
Tag/site #35 This 32-inch diameter tree is growing in a typically unrestricted growing space with a monolithic sidewalk and curb/gutter. The tree has a canopy that extends about 30 feet high and 60 feet wide. Initial stem bifurcation occurs about 20 feet up, progressive branching of primary and secondary scaffold limbs occurs throughout the canopy producing an especially high canopy architecture. Several of the scaffold limbs are long and horizontal and tend to be heavily loaded toward branch ends. Monitor the tree's stability on a routine basis; provide crown reconstruction pruning techniques along the long horizontal limbs to promote branch development and architectural structure closer toward the main stem, provide routine pruning techniques as needed, prune to maintain adequate clearance for vehicular traffic on High Street and pedestrian traffic along the sidewalk but, over time, develop well placed new sprouts to extend canopy architecture lower on the stem, prune to thin foliage on heavily laden limbs to avoid excessive strain, drooping, and possible breakage, routinely reduce horizontal canopy expansion by selectively cutting back terminal ends to appropriate-sized and well-placed lateral branches, avoid over pruning the tree (remove up to or less than but no more than 20 percent of the live foliage).

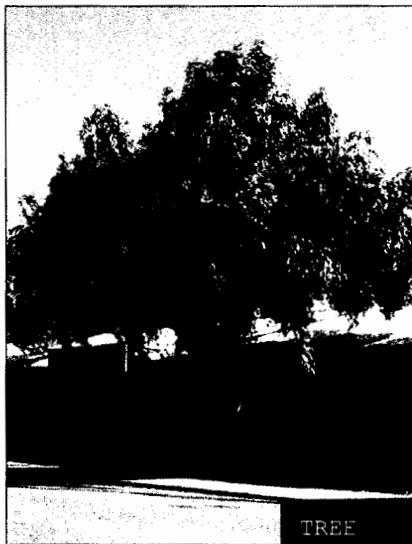
Tag/site #38 This 14-inch diameter tree is growing in an atypical growing space that is 5 feet deep – the tree trunk abuts a sidewalk section extended into the planter to accommodate an ornamental street lamppost. Imminent conflict is likely with the adjacent meandering sidewalk. Monitor the tree's stability and its impact on adjacent structure and infrastructure; provide routine pruning techniques as needed, prune to maintain adequate clearance for vehicular and pedestrian traffic and clearance from the building roof, prune to thin foliage on heavily laden limbs to avoid excessive strain, drooping, and possible breakage, avoid heading-back terminal ends and promote an upward growing canopy architecture, avoid over pruning the tree (remove up to or less than but no more than 20 percent of the live foliage). When an opportunity arises to replace the tree the new specimen should be accommodated by the growing space.

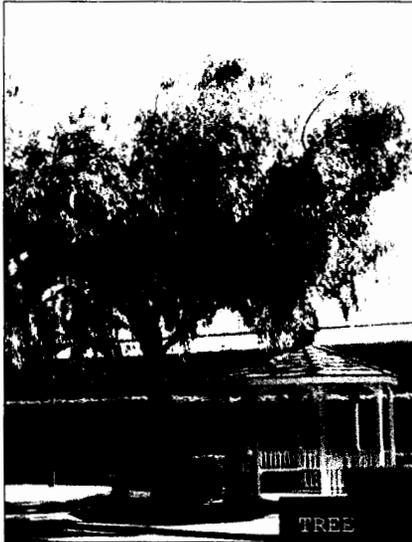
Tag/site #42 This 11-inch diameter tree is growing in an atypical growing space 4 feet east of brick paving (on the west side) and the tree's stem is 3 feet south of the sidewalk on the north side, which was extended to allow pedestrians to meander around an ornamental street lamppost. A potential future encroachment conflict is likely with the adjacent paved surfaces. The tree has a low, horizontal canopy architecture that extends about 18 feet above ground and westward, somewhat toward the gazebo. Monitor the tree's stability and its impact on adjacent structure and infrastructure; provide crown reconstruction pruning techniques along the long horizontal limbs to promote branch development and architectural structure closer toward the main stem, provide routine pruning techniques as needed, prune to maintain adequate clearance for vehicular and pedestrian traffic and clearance from the gazebo, prune to thin foliage on heavily laden limbs to avoid excessive strain, drooping, and possible breakage, avoid heading-back terminal ends and promote an upward growing canopy architecture, avoid over pruning the tree if possible but take necessary steps to redirect canopy development while maintaining tree health.

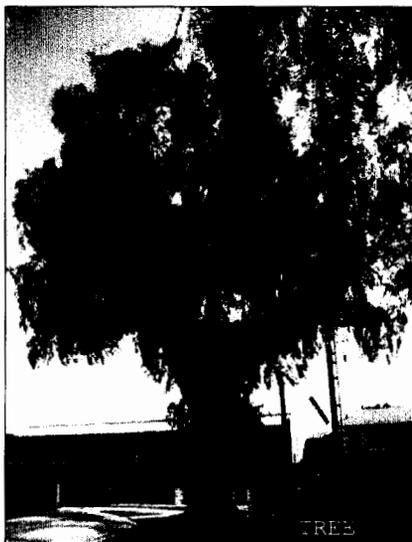
Tag/site #43 This 42-inch diameter tree is growing in an atypical growing space – and potential conflict is likely with the adjacent paved surfaces. Additional conflicts are likely with high voltage utility power lines that run along the south side of the tree. The tree has a canopy that extends about 40 feet high and 55 feet wide. Due to the phototropism and its effect on plant growth, portions of the tree canopy will have an inclination to encroach into the vicinity of these energized conductors. Unless maximum clearance standards are met, clearance pruning will occur by agents of the utility company and the interests of the tree will be secondary at best. (Utility line clearance is conducted in accordance with requirements of General Order 95, Rule 35 of The California Public Utilities Commission). Initial stem

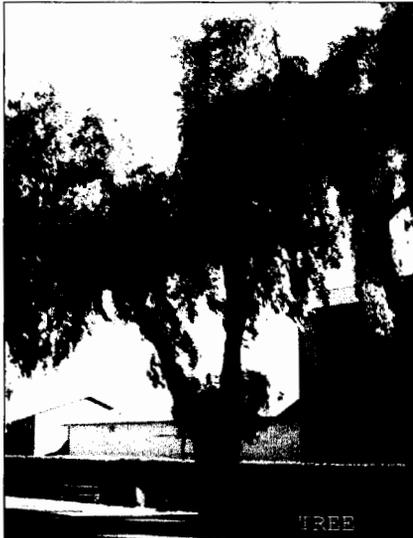
Tag/site #46 This 41-inch diameter tree is growing in a typically unrestricted growing space with a monolithic sidewalk and curb/gutter, though there is a concrete pad with a park bench a short distance to the east of the tree base. Other potential conflicts are possible with high voltage utility power lines that run along the south side of the tree. The tree has a canopy that extends about 50 feet high and 50 feet wide. This tree has a co-dominant stem architecture and initial stem bifurcation occurs about 6 feet up. Lateral branching secondary scaffold limbs occurs high in the canopy resulting in severe canopy architecture. Several of the secondary scaffold limbs are long and horizontal, and may develop a tendency to become overloaded toward branch ends. Monitor the tree's stability on a routine basis; provide crown reduction pruning techniques along the long horizontal limbs to promote branch development and architectural structure closer toward the main stem,

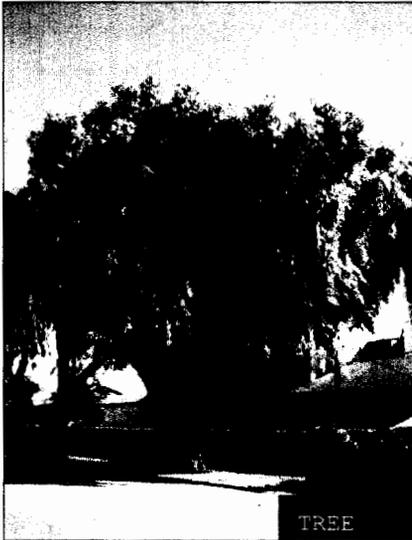
Tag/site #49 This 51-inch diameter tree is growing in a typically unrestricted growing space with a monolithic sidewalk and curb/gutter. The tree's canopy extends about 50 feet high and 70 feet wide. Three primary scaffold limbs bifurcate from the stem about 6 feet above grade and triangulate in such a fashion as to avoid the vicinity of power lines that run along the south side of the tree. A utility pole and associated communications lines are located beneath and extending through the canopy; this infrastructure has minor relevance to tree maintenance. Monitor the tree's stability on a routine basis; provide crown reconstruction pruning techniques along the long horizontal limbs to promote branch development and architectural structure closer toward the main stem, provide routine pruning techniques as needed, prune to maintain adequate clearance for vehicular traffic on High Street, prune to thin foliage on heavily laden limbs to avoid excessive strain, drooping, and possible breakage, routinely reduce horizontal canopy expansion by selectively cutting back terminal ends to appropriate-sized and well-placed lateral branches, avoid over pruning the tree (remove up to or less than but no more than 20 percent of the live foliage).

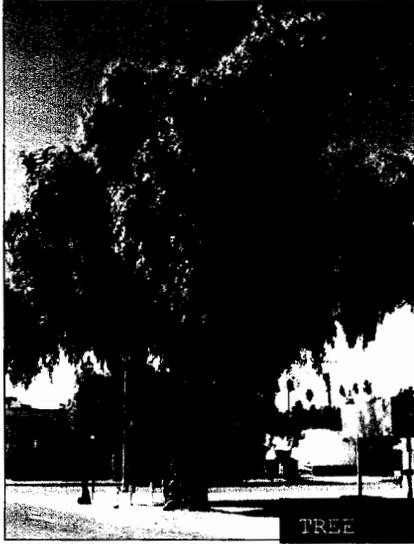
Tag/site #13 This 43-inch diameter tree is growing in a modified typically restricted growing space – the planter pops out into the roadway a distance of about 4 feet. Previous assessments indicate major problems with both root stability and scaffold stability, and extreme problems related to a large trunk cavity and decay. The tree has a pronounced lean to the north and has a canopy extending about 40 feet high and 60 feet wide. The initial stem bifurcation is about 10 feet up with 5 primary scaffold limbs and progressive branching of secondary scaffold and smaller branches and twigs throughout the canopy. Each of the scaffold limbs is long and horizontal and tends to be heavily loaded toward branch ends. Initiate extensive crown reconstruction pruning on an annual schedule for a minimum of 5 years; progressively reduce the length of long vertical and horizontal limbs each year to gradually promote branch development and architectural structure closer toward the main stem, delay other routine pruning techniques until crown reconstruction is well underway, safety prune to maintain adequate clearance for vehicular traffic on High Street and pedestrian traffic along the sidewalk but, over time, develop well placed new sprouts to extend canopy architecture lower on the stem.

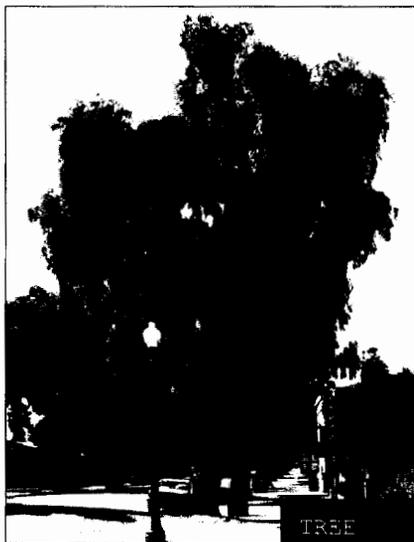
Tag/site #17 This 41-inch diameter tree is growing in a modified typically restricted growing space – the planter pops out into the roadway a distance of about 4 feet. Previous assessments indicate extreme problems with roots stability and trunk stability and major problems with the health of the roots. This tree's condition warrants ongoing consideration for its useful contribution to the grove. The tree's canopy extends about 50 feet high and 44 feet wide. The one large lateral limb originates about 8 feet up from grade; it is truncated about 10 above its point of origination. The primary

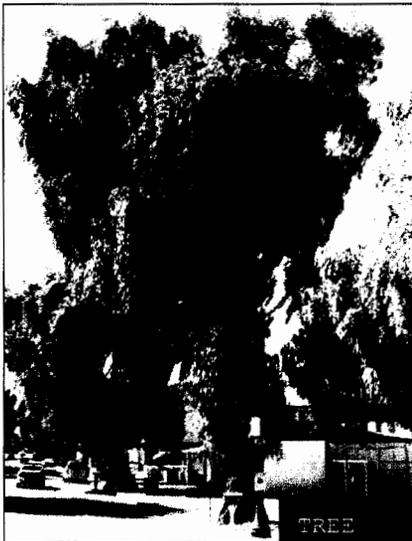
Tag/site #23 This 40-inch diameter tree is growing in a typically restricted growing space. Previous assessments indicate major problems with the stability of the trunk and the scaffold limbs. The tree's canopy extends about 40 feet high and 44 feet wide. This tree has co-dominant stem architecture and initial stem bifurcation occurs about 8 feet up. Lateral secondary scaffold limbs occur high in the canopy resulting in canopy architecture exerting severe leverage on weakened primary structure elements. Initiate extensive crown reconstruction pruning on an annual schedule for a minimum of 5 years; progressively reduce the length of long vertical and horizontal limbs each year to gradually promote branch development and architectural structure closer toward the main stem, delay other routine pruning techniques until crown reconstruction is well underway, safety prune to maintain adequate clearance for vehicular traffic on High Street and pedestrian traffic along the sidewalk but, over time, develop well placed new sprouts to extend canopy architecture lower on the stem.

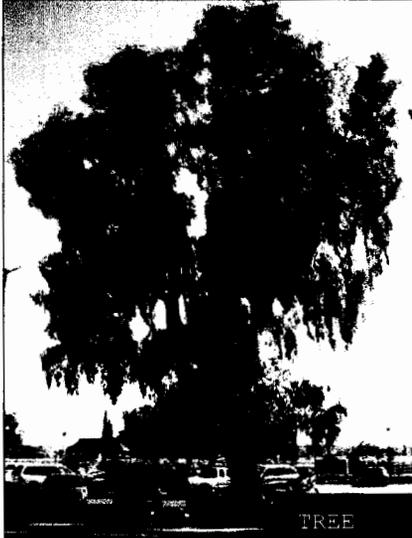
Tag/site #30 This 37-inch diameter tree is growing in an atypical growing space – 19 feet wide and 26 feet deep, with a monolithic sidewalk and curb/gutter. Previous assessments indicate major problems with the health and stability of the trunk and the scaffold limbs. The tree’s canopy extends about 40 feet high and 47 feet wide. The initial stem bifurcation is about 15 feet up, with 3 primary scaffold limbs and secondary scaffold and smaller branches and twigs throughout the canopy. Several of the major lateral limbs are long, horizontal, and tend to be heavily loaded toward branch ends. Initiate extensive crown reconstruction pruning on an annual schedule for a minimum of 5 years; progressively reduce the length of long vertical and horizontal limbs each year to gradually promote branch development and architectural structure closer toward the main stem, delay other routine pruning techniques until crown reconstruction is well underway, safety prune to maintain adequate clearance for vehicular and pedestrian traffic.

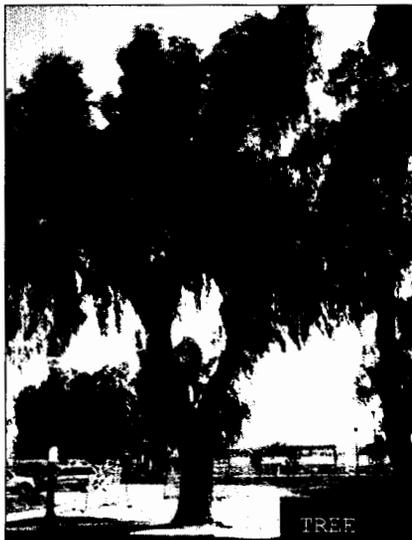
Tag/site #31 This 36-inch diameter tree is growing in a typically unrestricted growing space with a monolithic sidewalk and curb/gutter. Previous assessments indicate major problems with the health and stability of the trunk and the stability of scaffold limbs. The tree’s canopy extends about 35 feet high and 52 feet wide. This tree has a co-dominant stem architecture and initial stem bifurcation occurs about 8 feet up. Lateral primary scaffold limbs occur high in the canopy resulting in an elevated canopy form. Initiate extensive crown reconstruction pruning on an annual schedule for a minimum of 5 years; progressively reduce the length of long vertical and horizontal limbs each year to gradually promote branch development and architectural structure closer toward the main stem, delay other routine pruning techniques until crown reconstruction is well underway, safety prune to maintain adequate clearance for vehicular and pedestrian traffic but, over time, develop well placed

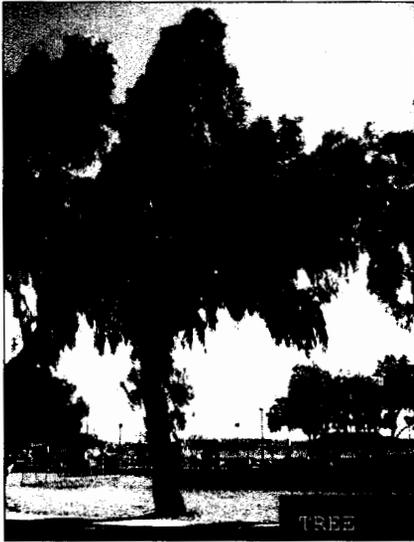
Tag/site #32 This 25-inch diameter tree is growing in a typically unrestricted growing space with a monolithic sidewalk and curb/gutter. Previous assessments indicate extreme problems with root stability and major problems with trunk and scaffold stability and scaffold health. The tree's canopy extends about 30 feet high and 43 feet wide with most of the canopy on a north south axis due to its close proximity to an adjacent tree (#31). The main stem bifurcation is about 15 feet up. Initiate extensive crown reconstruction pruning on an annual schedule for a minimum of 5 years; progressively reduce the length of long vertical and horizontal limbs each year to gradually promote branch development and architectural structure closer toward the main stem, delay other routine pruning techniques until crown reconstruction is well underway, safety prune to maintain adequate clearance for vehicular and pedestrian traffic but, over time, develop well placed new sprouts to extend canopy architecture lower on the stem.

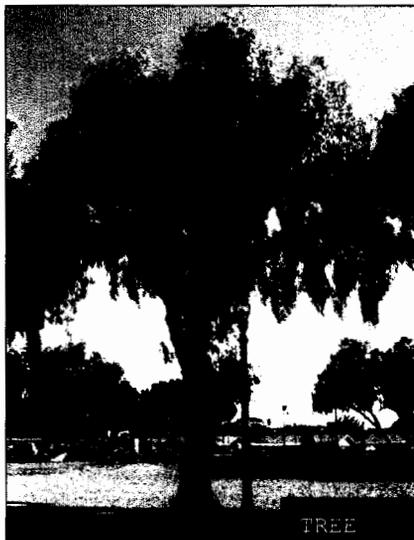
Tag/site #33 This 30-inch diameter tree is growing in a typically unrestricted growing space with a monolithic sidewalk and curb/gutter. Previous assessments indicate major problems with root stability. The tree's canopy extends about 30 feet high and 39 feet wide. This tree has a co-dominant stem architecture and initial stem bifurcation occurs about 15 feet up. Lateral primary scaffold limbs occur high in the canopy resulting in an elevated canopy form. Initiate extensive crown reconstruction pruning on an annual schedule for a minimum of 5 years; progressively reduce the length of long vertical and horizontal limbs each year to gradually promote branch development and architectural structure closer toward the main stem, delay other routine pruning techniques until crown reconstruction is well underway, safety prune to maintain adequate clearance for vehicular

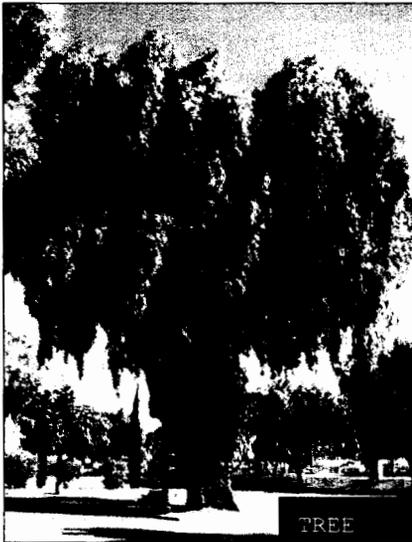
Tag/site #36 This 59-inch diameter tree is growing in a typically unrestricted growing space with a meandering sidewalk, placing the tree in an open space between the sidewalk and High Street. A park bench is located on the north side between the tree and High Street, directly under the lean. Previous assessments indicate extreme problems with root health, major problems with root stability and scaffold limb stability, and due to a large cavity and decay major problems with the trunk health. The tree's canopy extends about 45 feet high and 66 feet wide. This tree has a co-dominant stem architecture and initial stem bifurcation occurs about 15 feet up. Lateral primary scaffold limbs occur high in the canopy resulting in an elevated canopy form. The initial stem bifurcation is about 10 feet up with additional bifurcation of scaffold limbs about 5 feet higher. Many of the scaffold limbs are long and horizontal and tend to be heavily loaded toward branch ends. Remove the park bench away from this location and relocate it where it will not present a potential high risk for damage or injury in case of tree failure. Initiate extensive crown reconstruction pruning on an annual schedule for a minimum of 5 years; progressively reduce the length of long vertical and horizontal limbs each year to gradually promote branch development and architectural structure closer toward the main stem, delay other routine pruning techniques until crown reconstruction is well underway, safety prune to maintain adequate clearance for vehicular and pedestrian traffic but, over time, develop well placed new sprouts to extend canopy architecture lower on the stem.

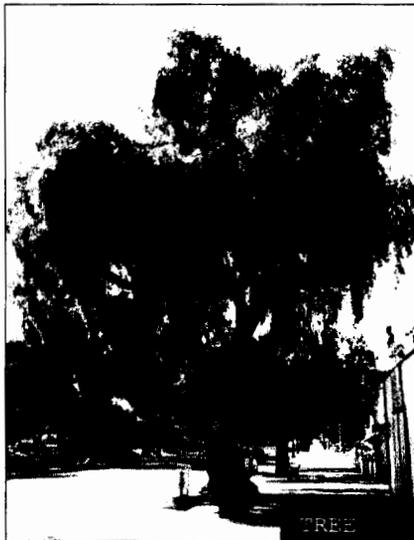
Tag/site #22 This 48-inch diameter tree is growing in a modified typically restricted growing space – the planter pops out into the roadway a distance of about 4 feet. The tree has a canopy that extends about 45 feet high and 53 feet wide. Previous assessments indicate extreme problems with root stability, trunk stability, and scaffold limb stability and the tree has a severe lean to the west. Due to conditions of instability that cannot be mitigated the tree should be removed at the earliest opportunity, the site should be prepared for replanting and a new tree should be installed at this location. Please see planting specifications, enclosed.

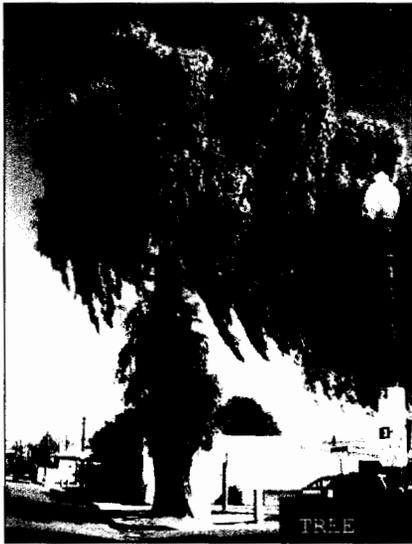
Tag/site #26 This 52-inch diameter tree is growing in a modified typically restricted growing space – the planter pops out into the roadway a distance of about 4 feet. The tree has a canopy that extends about 45 feet high and 43 feet wide. Previous assessments indicate extreme problems with trunk stability and scaffold limb stability. Due to conditions of instability that cannot be mitigated the tree should be removed at the earliest opportunity and the site should be studied for its appropriateness as a designated tree site or a site designated as part of the historic California Pepper grove. If it is determined that replanting is appropriate a new tree may be installed at this location. Please see planting specifications, enclosed.
