**MOORPARK CITY COUNCIL
AGENDA REPORT**

SUBJECT: Consider the California Pepper Trees Maintenance Plan and Final Environmental Impact Report

California Pepper Grove – High Street Moorpark, California

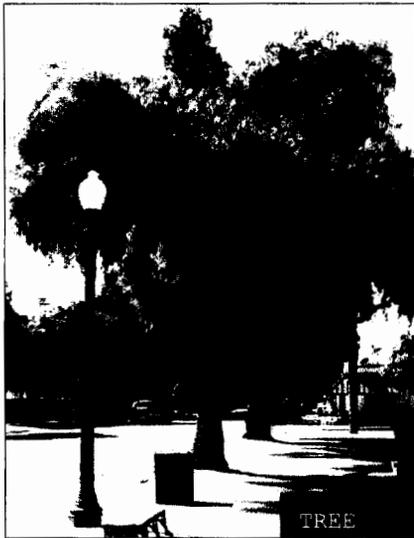
Tag/site #14 This 25-inch diameter tree is growing in a modified typically restricted growing space – the planter pops out into the roadway a distance of about 4 feet. The tree has a canopy that extends about 20 feet high and as wide. Multiple primary scaffold limbs originate from the main stem about 12 feet up from grade and support a dense, asymmetrical canopy. Monitor the tree's stability

on a routine basis; provide crown reconstruction pruning techniques to improve scaffold branch attachment and arrangement, provide routine pruning techniques as needed, prune to provide adequate clearance for vehicular traffic on High Street and pedestrian traffic along the sidewalk, prune to thin foliage on heavily laden limbs to avoid excessive strain, drooping, and possible breakage, avoid heading-back terminal ends and promote an upward growing canopy architecture, avoid over pruning the tree if possible but take necessary steps to redirect canopy development while maintaining tree health.

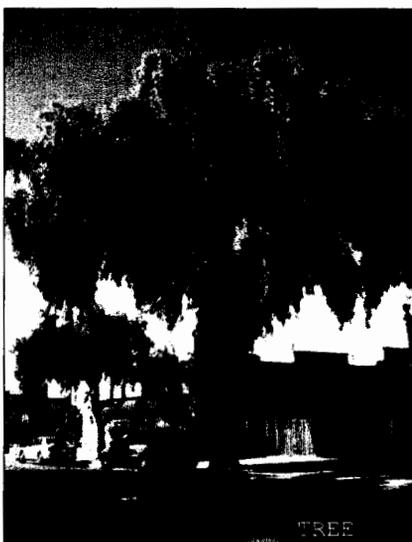
Tag/site #49 This 51-inch diameter tree is growing in a typically unrestricted growing space with a monolithic sidewalk and curb/gutter. The tree's canopy extends about 50 feet high and 70 feet wide. Three primary scaffold limbs bifurcate from the stem about 6 feet above grade and triangulate in such a fashion as to avoid the vicinity of power lines that run along the south side of the tree. A utility pole and associated communications lines are located beneath and extending through the canopy; this infrastructure has minor relevance to tree maintenance. Monitor the tree's stability on a routine basis; provide crown reconstruction pruning techniques along the long horizontal limbs to promote branch development and architectural structure closer toward the main stem, provide routine pruning techniques as needed, prune to maintain adequate clearance for vehicular traffic on High Street, prune to thin foliage on heavily laden limbs to avoid excessive strain, drooping, and possible breakage, routinely reduce horizontal canopy expansion by selectively cutting back terminal ends to appropriate-sized and well-placed lateral branches, avoid over pruning the tree (remove up to or less than but no more than 20 percent of the live foliage).

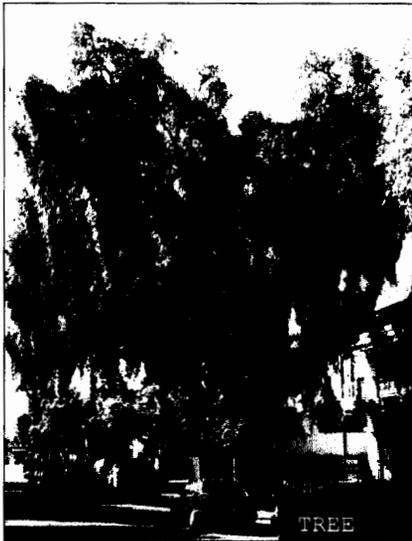
Tag/site #9 This 40-inch diameter tree is growing in a typically restricted growing space. In addition to paving/surface restrictions the tree is situated in close proximity to the adjacent tree (#8); they were planted 20 feet on center. Allowing for reasonable canopy extension and healthy long-term development, a minimum specification for trees this size should be 30 feet on center. Previous assessments indicate extreme problems with trunk stability and major problems with both the health of scaffold limbs and smaller branches and twigs. The tree's canopy extends about 55 feet high and 60 feet wide. The initial stem bifurcation is about 10 feet up, progressive branching of secondary scaffold limbs occurs throughout the canopy producing an extensive canopy architecture. Most or all of the scaffold limbs are long and horizontal and tend to be heavily loaded toward branch ends. Initiate extensive crown reconstruction pruning on an annual schedule for a minimum of 5 years; progressively reduce the length of long vertical and horizontal limbs each year to gradually promote branch development and architectural structure closer toward the main stem, delay other routine pruning techniques until crown reconstruction is well underway, safety prune to maintain adequate clearance for vehicular traffic on High Street and pedestrian traffic along the sidewalk

but, over time, develop well placed new sprouts to extend canopy architecture lower on the stem.

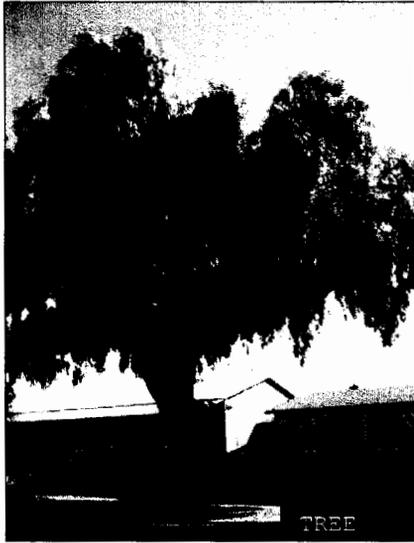
Tag/site #44 This 33-inch diameter tree is growing in a typically unrestricted growing space with a meandering sidewalk, placing the tree in an open space between the

sidewalk and High Street. A potential aerial conflict exists with high voltage utility power lines that run along the south side of the tree. Previous assessments indicate extreme problems with scaffold limb stability, and major problems with trunk stability and scaffold limb health. The tree bifurcates at about 10 up with 3 primary scaffolds, progressive branching of secondary scaffold limbs occurs producing an extensive canopy supported by long lateral limbs that tend to be heavily loaded toward branch ends. Initiate extensive crown reconstruction pruning on an annual schedule for a minimum of 5 years; progressively reduce the length of long vertical and horizontal limbs each year to gradually promote branch development and architectural structure closer toward the main stem, delay other routine pruning techniques until crown reconstruction is well underway, safety prune to maintain adequate clearance for vehicular and pedestrian traffic but, over time, develop well placed new sprouts to extend canopy architecture lower on the stem.

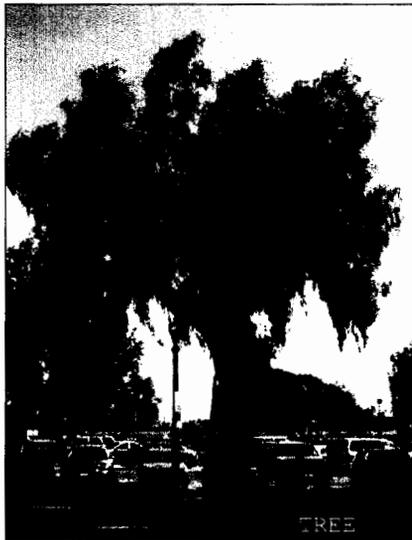
Tag/site #29 This 33-inch diameter tree is growing in a modified typically restricted growing space – the space is a 5-foot by 5-foot planter and the tree's trunk is approximately 1-foot away from the paving in each direction. The tree has a canopy that extends about 35 feet high and 39 feet wide. Previous assessments indicate extreme problems with trunk stability and scaffold limb stability. Due to conditions of instability that cannot be mitigated the tree should be removed at the earliest opportunity and the site should be studied for its appropriateness as a designated tree site or a site designated as part of the historic California Pepper grove. If it is determined that replanting is appropriate a new tree may be installed at this location.

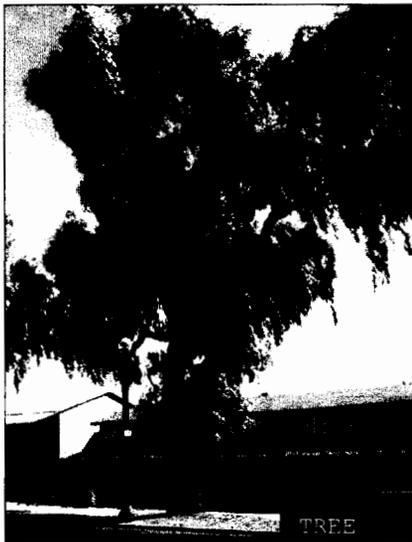
Tag/site #45 This 35-inch diameter tree is growing in a typically unrestricted growing space with a meandering sidewalk and concrete pads with park benches a short distance from the tree base on both the east and west sides. In addition, high voltage utility power lines that run along the south side of the tree. The tree has a canopy that extends about 45 feet high and 45 feet wide. Previous assessments indicate extreme problems with trunk stability and major problems with scaffold limb stability. Due to conditions of instability the tree should be removed at the earliest opportunity, the site should be prepared for replanting and a new tree should be installed at this location. Please see planting specifications, enclosed.
